RECONNAISSANCE OBSERVATION FROM MAY 12 CHINA EARTHQUAKE

Chu-Chieh Jay LIN*

Associate Research Fellow, National Center for Research on Earthquake Engineering, Taipei, Taiwan*

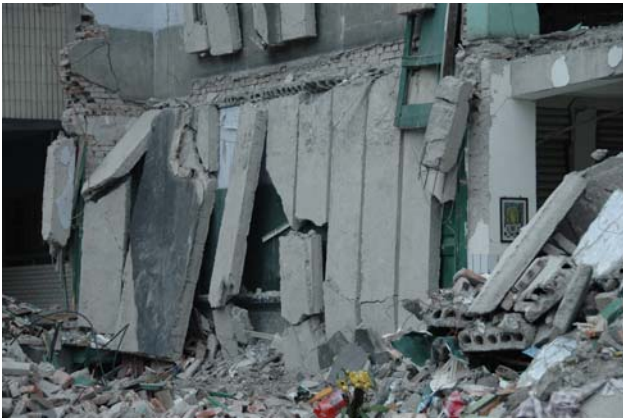
(URM) and brick (masonry) buildings. The URM buildings are a unique structural system which consists of vulnerable brick columns, reinforced concrete beams, and precast concrete hollow floor planks with wire mesh (figure 1). Most of the public buildings are constructed using RC and URM systems, while most of the residential houses and school classrooms were made of URM with 4-7 stories and bricks with only one or two stories.

Fig. 1 The close-up view of the collapsed classroom

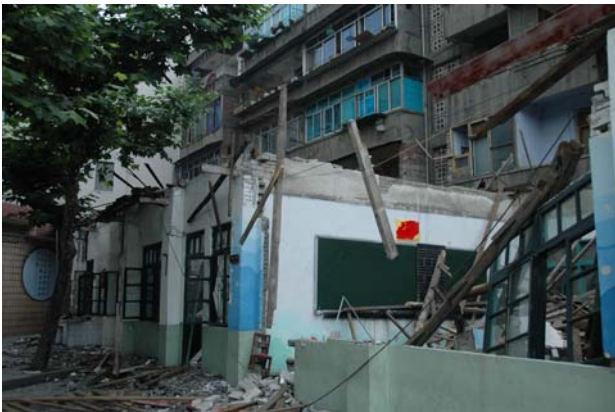
Fig. 2 The collapsed masonry classrooms

A significant number of injuries and casualties were associated with the total collapse of the school, commercial and residential buildings. Figures 2-6 show the collapsed buildings of elementary schools as well as failure and damage of commercial-residential buildings at Dujiangyan. Due to lack of ductile structural elements in the URM and

masonry buildings to resist the seismic lateral force, the structural collapse and its consequences lead to human life losses and injuries are inevitable during a severe earthquake.

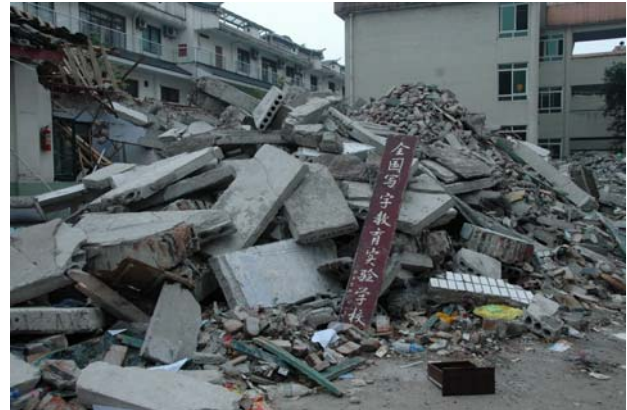
Fig. 3 The collapsed URM building in school

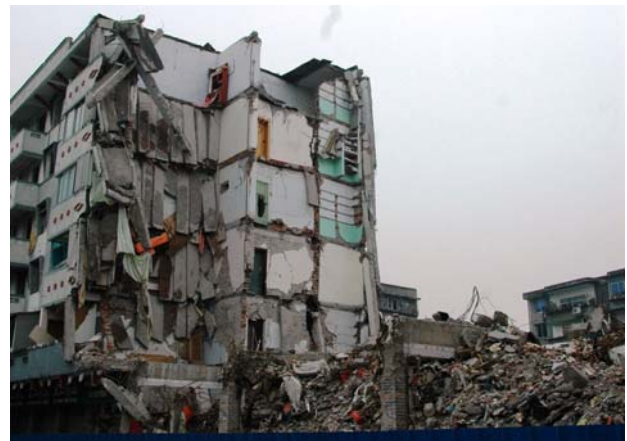
Fig. 4 The collapsed residential buildings (URM)

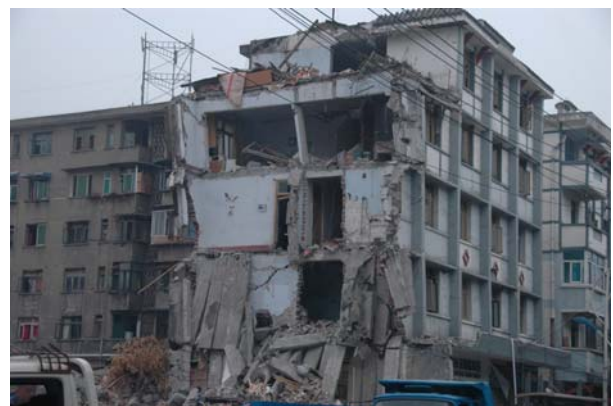
Fig. 5 The collapsed residential buildings (URM)

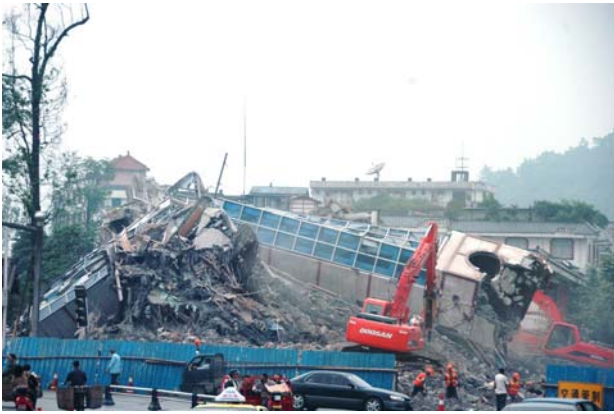
Fig. 6 The collapsed commercial buildings

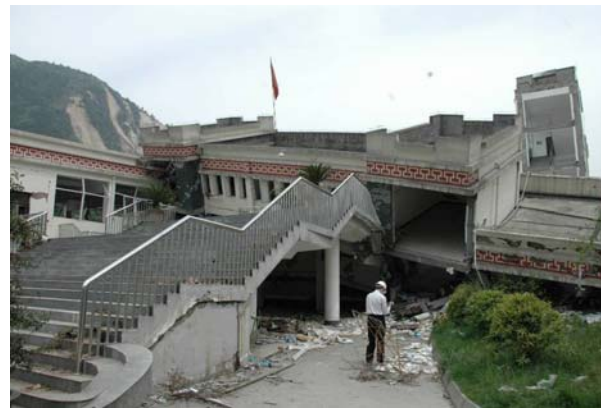
Fig. 9 The collapsed RC school building

Even the engineered RC buildings were experienced severe damage or collapse because of the strong shaking of the earthquake when near the epicenter; figures 7-10 show such damages in Hsuanko High School at Yingxiu (Wenchuan).

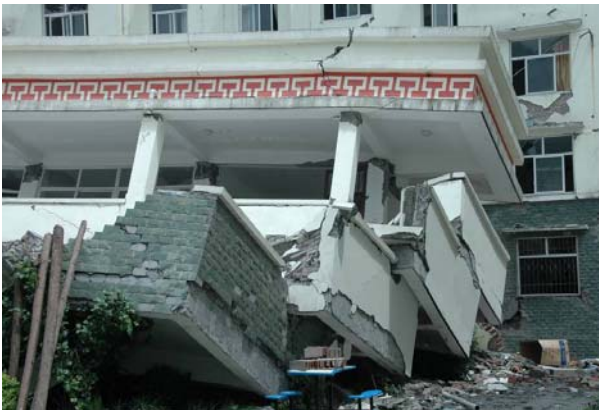
Fig. 7 The collapsed RC school building

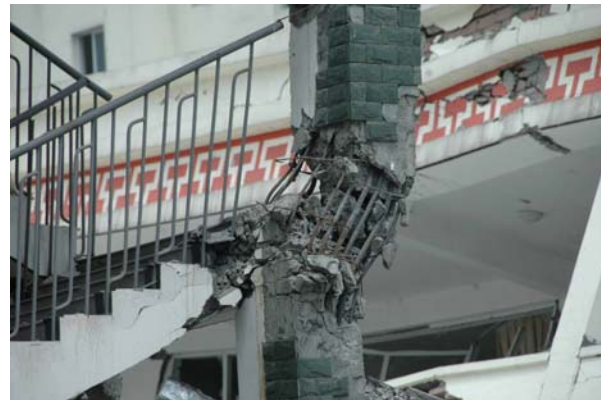
Fig. 10 The close-up of a damaged RC column

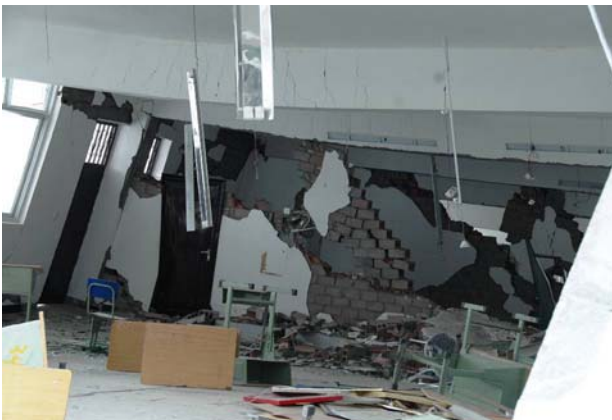
Fig. 8 The damaged classroom

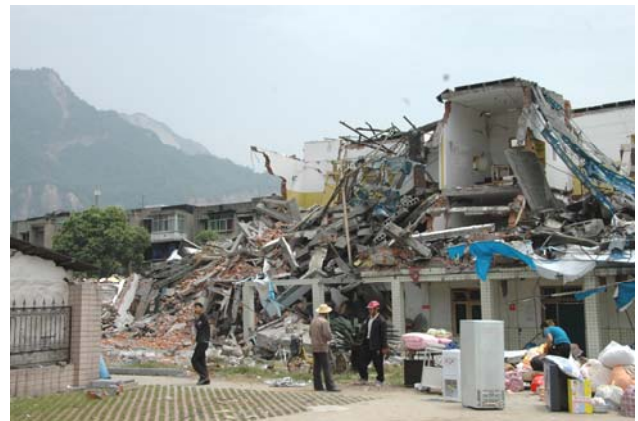
Fig. 11 The collapsed dormitory of a hospital

The hospitals suffered damages of different degrees from moderate to severe so they were not able to operate with normal function to rescue the injured and save lives right after this natural catastrophe. Figure 11 shows the collapsed buildings of a hospital at Hanwang. Figures 12-14 show hospitals with no

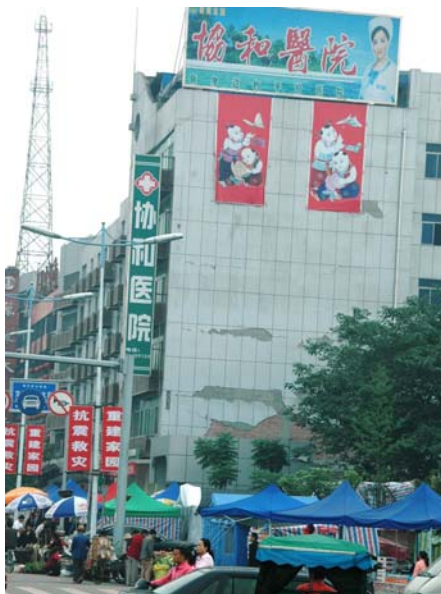
service due to partial damages or lack of water and power.

Fig. 12 The hospital suffered medium damages

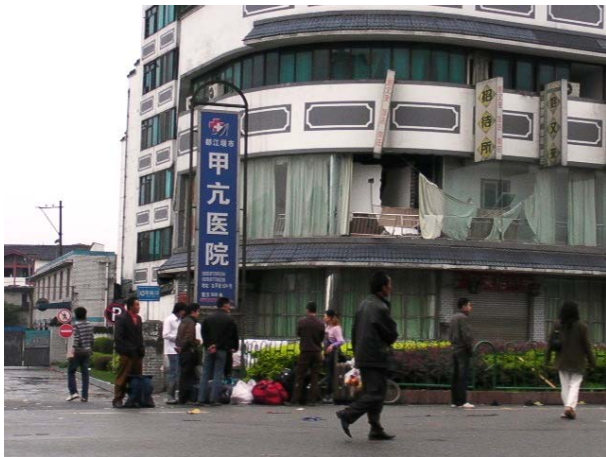
Fig. 13 The structural damages of a hospital

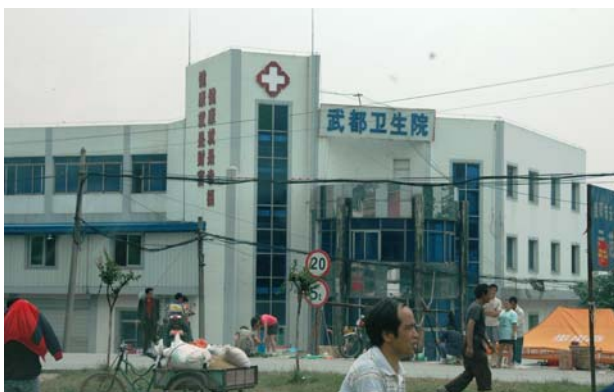
Fig. 14 The hospital is out of service

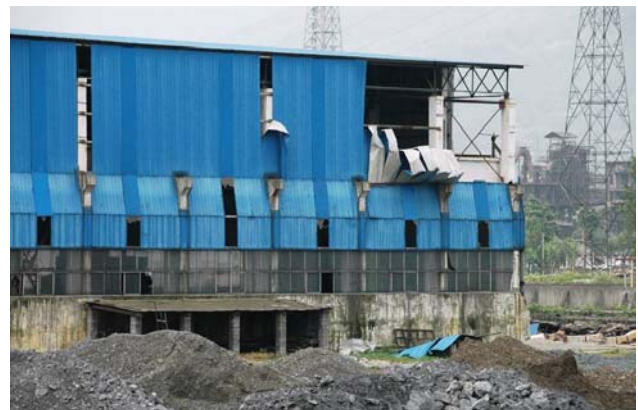
Most of the factories suffered structural or non-structural damages in this earthquake. The operations were almost shut down due to these damages as well as lack of electricity. Figures 15-17 show the damaged factories. However, there is a precast concrete factory in the affected area remains operation after the earthquake and provide enormous help to the community (figure 18).

Fig. 15 The damaged factory

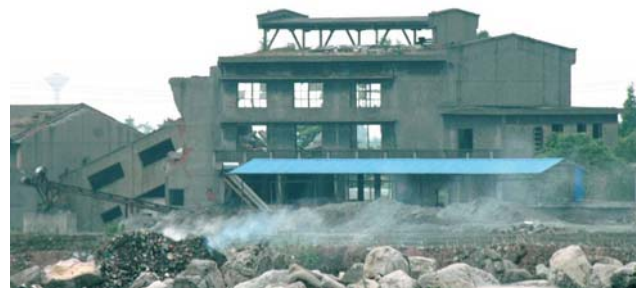
Fig. 16 The collapsed factory

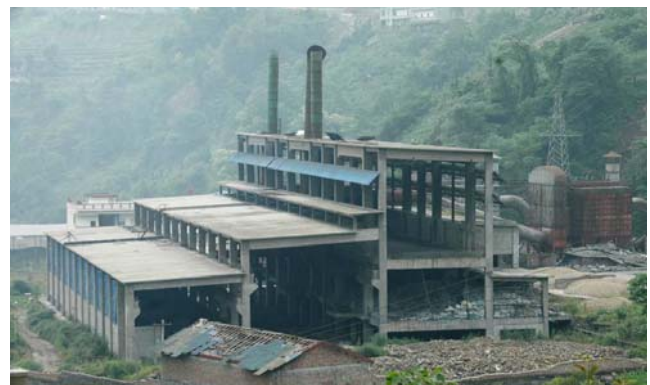
Fig. 17 The mess in the factory

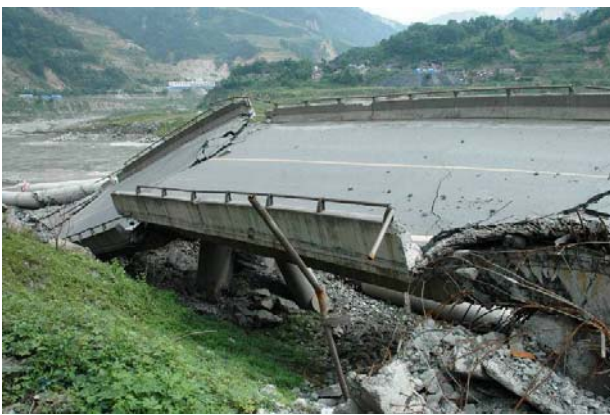
Fig. 23 The collapsed decks of Baihwa bridge

Baihwa Bridge is a reinforced concrete (RC) slab beam continuous bridge supported by twin column pier with cap beam on expansion joint. It is a 500 m long, 30 m height viaduct and plays a critical role on the route from Dujiangyan to Wenchuan when

opened to traffic since 2004. There are about 50 m long bridge slab collapsed on the location of the turning section after earthquake as shown in figures 23 and 24. Due to the safety reason, the un-collapsed part of Baihwa Bridge is demolished using explosives to reduce the threat to the emergency path underneath the bridge.

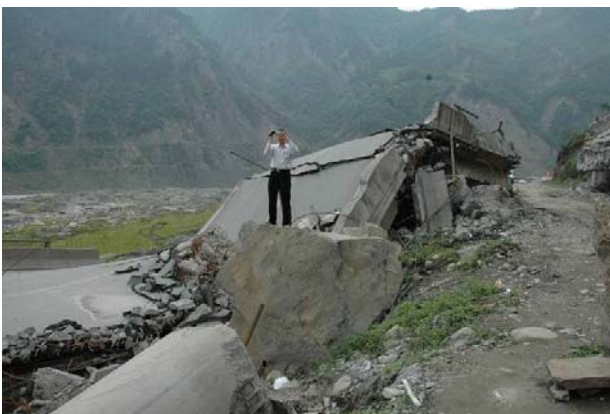
Fig. 24 The collapsed Baihwa bridge

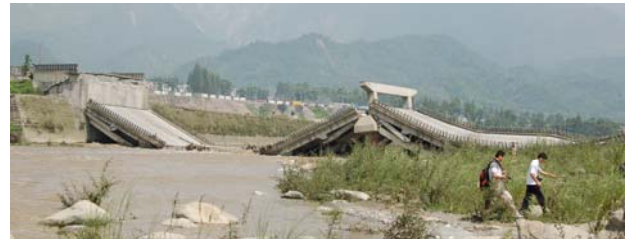
Fig. 25 The collapsed spans of Xiaoyudong bridge

Xiaoyudong Bridge was a four-span RC arch bridge

as shown in figures 25-27. The fault rupture and the strong motion of the earthquake caused the collapses of two spans and severely damaged the rest of the bridge. The destruction of the embankment, abutment and the barrier, the buckling of the arch, as well as the shifting of the road surface are all observed to witness the enormous pressure of the strong earthquake motion.

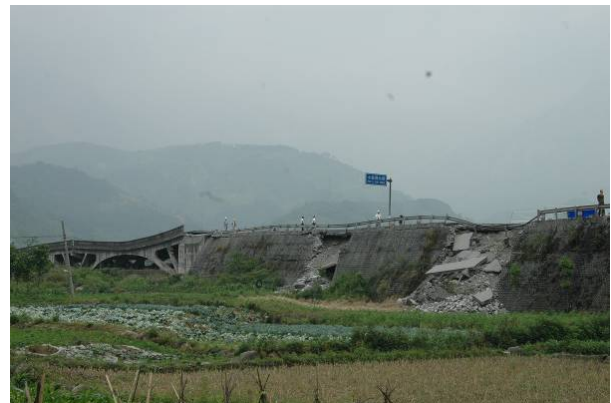
Fig. 26 Fault rupture went through the embankment of Xiaoyudong bridge

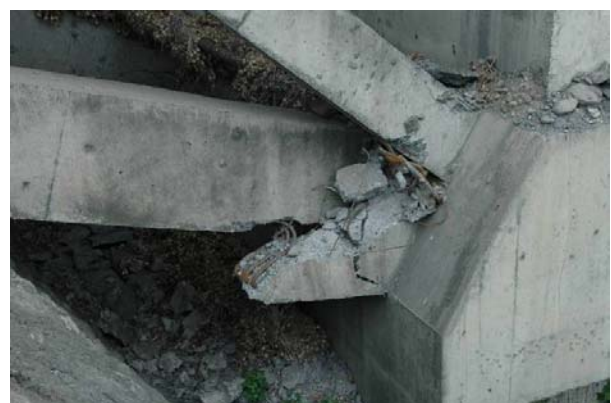
Fig. 27 The fractured element of Xiaoyudong bridge

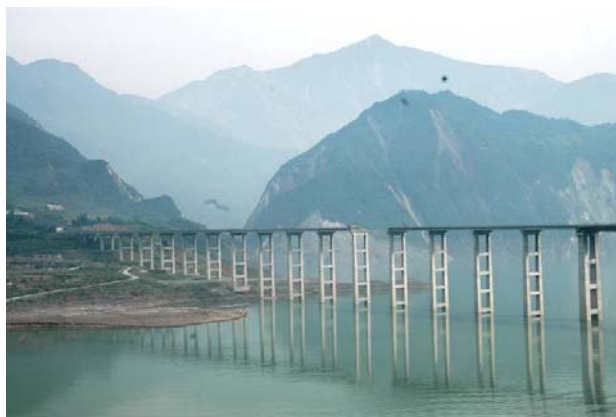
Fig. 28 The falling span of Miaotzuping bridge

As shown in figure 28, Miaotzuping Bridge is located at the Zipingpu dam water reservoir area near Dujiangyan. This beautiful bridge is 1436 m long with 108 m height composed of main bridge (long span continuous box girder type) and 19 approaches (T-girder simple supported with continuous deck). Though the main construction of the bridge is completed but it is not opened to traffic yet since the unfinished facilities. There are spans shifting on both longitudinal and horizontal directions causing the damages of shear keys on both sides. Furthermore, the earthquake caused one of the T-girder approaches collapsed due to possible insufficient support length of cap beam for falling prevention (narrow seat).

- (3) Some common seen bridge failures such as insufficient length of seat width, cut-off lap-splice position, and lack of restrainer were still found in this China earthquake. Therefore, it is strongly recommended adopting the latest knowledge of disaster-prevention from other countries, so that the possible loss from earthquake can be minimized.

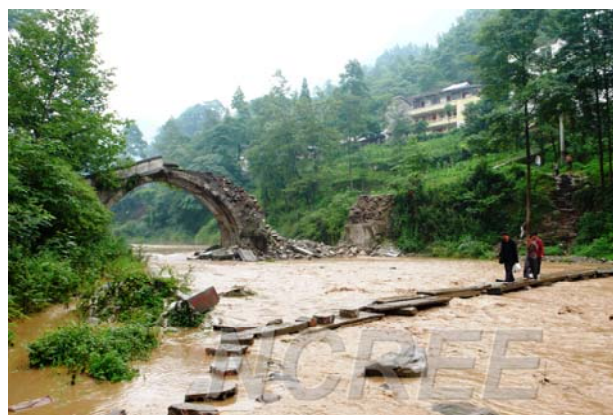
Figure 29 shows a destroyed ancient masonry arch bridge at Bailu. In addition, the rest of the bridges on

Fig. 29 The destroyed arch bridge in Bailu

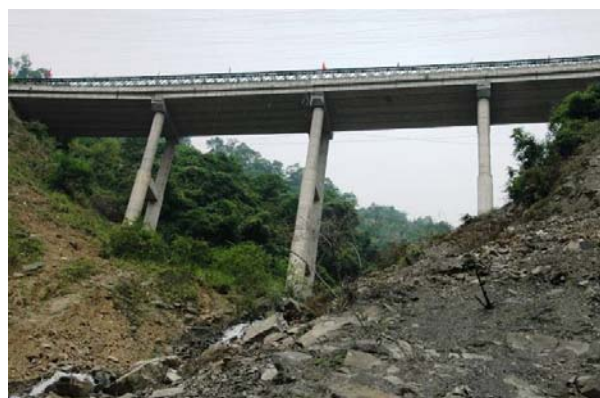
National Highway 213 were all suffered different degree of damage such as shifting, cracks on bridge support, and destructions of side stoppers (shear keys), as shown in figure 30. Since the bridges play very important roles on transportation and it is critical for emergency rescue and response tasks, the slightly damaged bridges were temporary retrofitted by Bailey bridge with speed and weight limit (figure 31).

Fig. 30 The damaged bridge in Highway 213

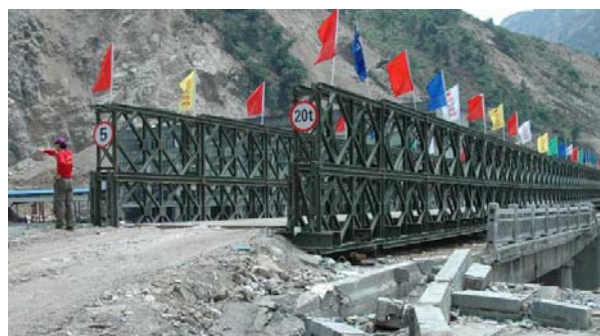
Fig. 31 The speed and weight limits on the Baileys

Also shown in figure 31, the bridges at Mianzhu city suffered slight damages on expansion joints although most of the bridges at metropolitan cities remain intact.

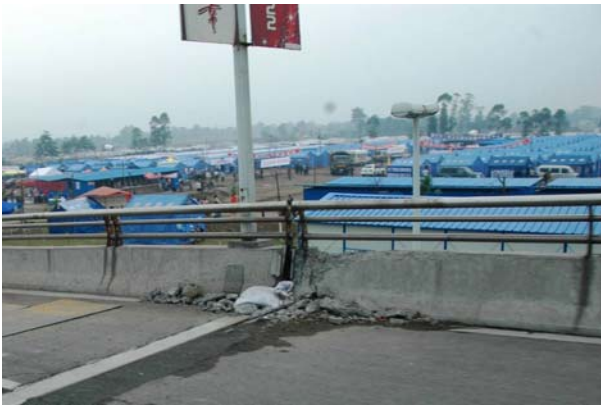
Fig. 32 The damaged expansion joint
