SITUATION AND CHARACTERISTICS OF TSUNAMI DAMAGE TO THE TIDE WALLS ALONG THE COAST IN IWATE PREFECTURE RESULTING FROM THE GREAT EAST JAPAN EARTHQUAKE

Tetsuya Oyamada,* Shunsuke Hanehara,* Hideaki Deto,* Shoji Iwasaki*

Iwate University *

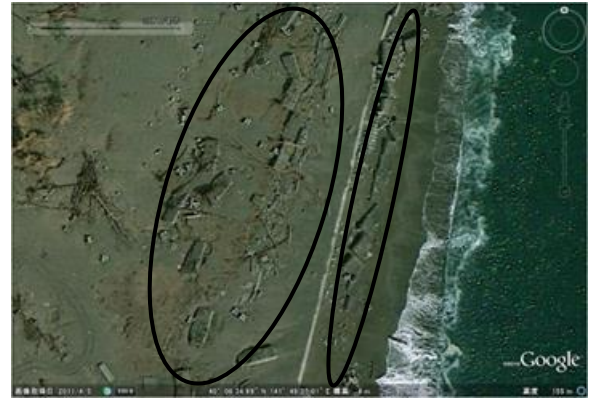
Figure-3 Aerial Photograph of Tofugaura Coast (No. 1)

Figure-3 shows an aerial photograph of the severely damaged Tofugaura Coast area (**No. 1**). The slightly inclined vertical white line falling a little to the right of the photograph's center indicates that a concrete foundation and concrete superstructures are scattered on both the sea and land sides. A section of the damaged tide wall is shown in **Figure-4**. There is sea sand inside the wall's structure. **Figure-5** shows the collapsed tide wall. In this area, the sea side slope, or the front side slope, of the tide wall has collapsed toward the sea, the concrete blocks which protected the back slope have fallen towards the land side, and the infill sand has flowed out. This damage suggests that spilling waves first knocked down the concrete blocks and scoured the infill sand, the backrush then causing the front slope to fall down.

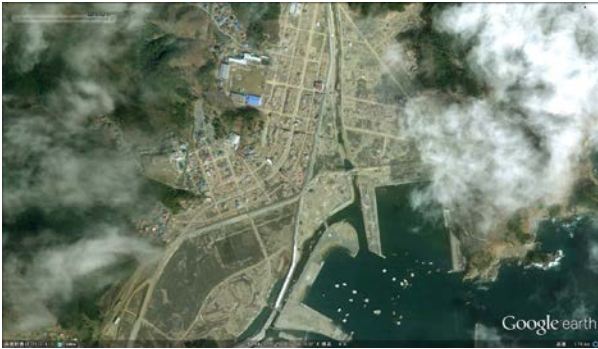
Figure-6 Aerial Photograph of Coast at Taro Fishery Port (No. 2)

Figure-6 shows an aerial photograph of the coast at Taro Fishery Port (**No. 2**). In this area, two tide walls intersect at their centers to form an X shape. The tsunami overflowed both of them and damaged the

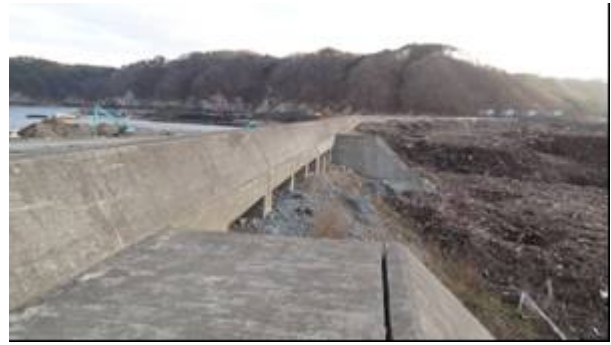
Figure-7 Damaged Tide Wall (South Side) (No. 2)

shore side tide walls. The southern parts of the tide walls had the surface of the back slopes torn off and the infill sand washed out, as shown in [Figure-7](#). In contrast, their northern parts suffered more devastating damage. [Figure-8](#) shows the damage to the northern part photographed from the sea side. The concrete blocks of the front side slope have been knocked down and the infill sand washed out. Only the concrete which supported the front slope

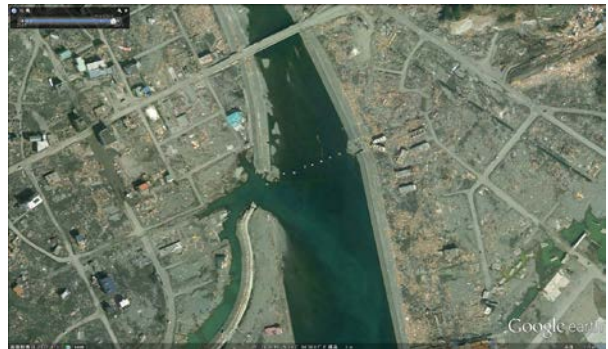
Figure-9 Aerial Photograph of Otsuchi River Bank (No. 6)

[Figure-9](#) shows an aerial photograph of the Otsuchi River ([No. 6](#)) bank after damage by the tsunami. It can be seen that the river bank has been broken and the rear side of the bank flooded with overflowed water. The back slope of the damaged river bank is shown in [Figure-10](#). Similar to the other cases described above, the concrete blocks of the river banks have slipped off, as shown in [Figure-11](#), and

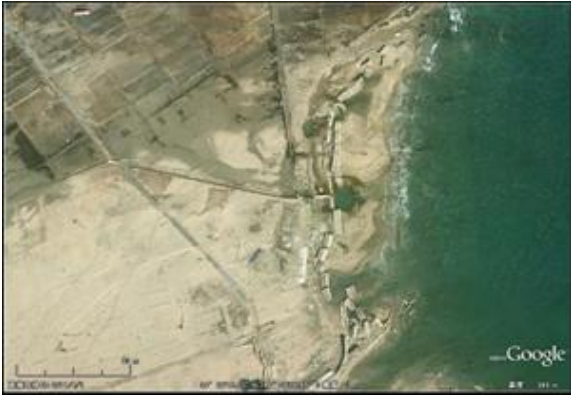
Figure-12 Aerial Photograph of Coast at Yoshihama Agricultural Field (No. 8)

Figure-12 shows an aerial photograph of the coast at Yoshihama Agricultural Field (No. 8) after the tsunami. The white line in the photograph indicates the location of the tide wall before the disaster, its total length being around 0.6 km. The wall collapsed toward the sea side along its entire length. The seaward collapse of the main body of the wall can be

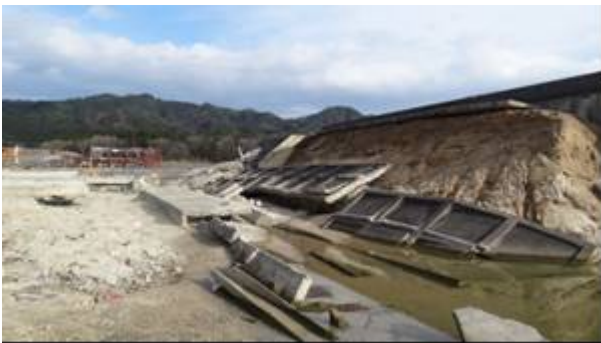
Figure-14 Damage to Tide Wall (No. 4)

The tide wall on the Koyadori Coast (No. 4) also had the back slope torn off and the infill sand washed out, as shown in Figure-14. The damage to the front slope of the wall is shown in Figure-15. Judging from these observations, the backrush is believed to be the reason for the seaward collapse of the tide wall.

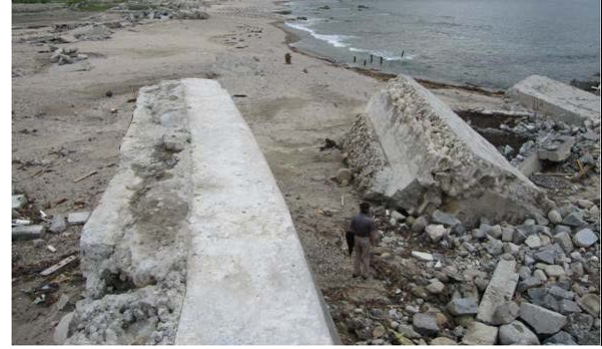
Figure-13 Damage to Tide Wall (No. 8)

seen in Figure-13.

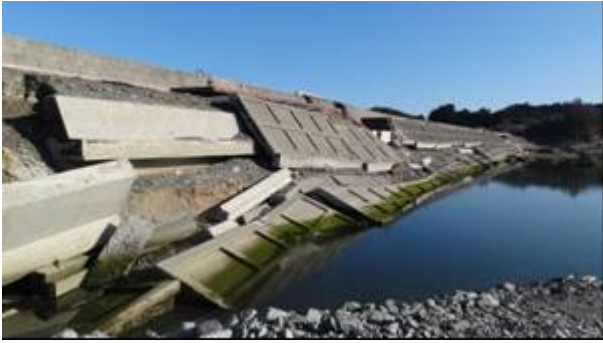
Figure-16 Damage to Tide Wall (No. 10)

In the case of the tide wall on the Mutsugahama Coast (No. 10), the back slope slid down and the infill sand was washed out, as shown in Figure-16. The damage to the front slope of the same tide wall is shown in Figure-17. The concrete blocks were bent at around the center in a vertical direction but no displacement of the wall was observed. This situation suggests that a preceding scouring of the infill sand lessened the support of the concrete blocks.

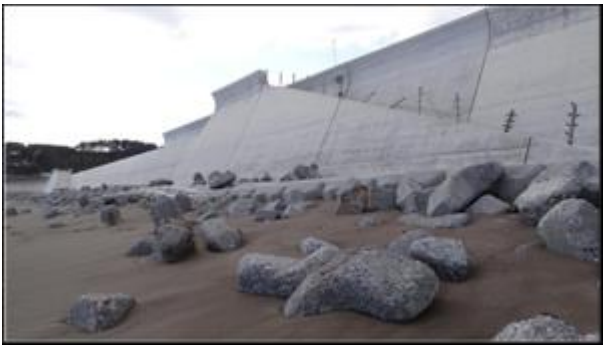
Figure-18 Tide Wall which Did Not Collapse (No. 1)

been constructed. The back slope of the wall was lost and part of the infill sand washed out, but the tide wall itself was saved from collapse, as shown in **Figure-18**. This wall is known to have been constructed at a different time from the other structures. Since we believe that this tide wall can provide valuable information on how to protect tide walls from future tsunami disasters, we are currently studying its details.

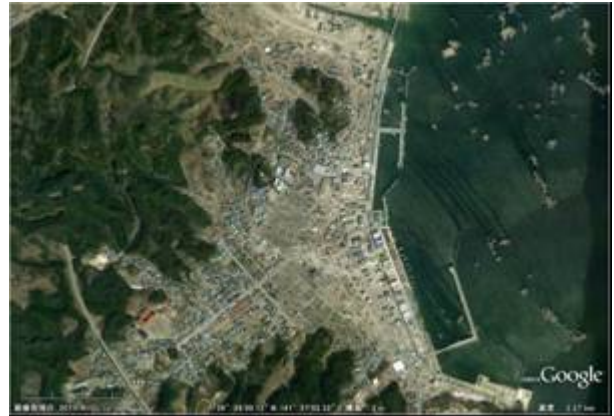
Figure-19 Aerial Photograph of Coast at Yamada Fishery Port (No. 3)

Figure-19 shows an aerial photograph of the coast at Yamada Fishery Port (**No. 3**) after the disaster. In this area, a self-standing tide wall had been

constructed, with a total length of 1.3 km. A large part of the tide wall remains nearly unaffected by the tsunami, except for a severely damaged section of length 0.2 km. In the damaged section, some segments fell down from their bases and others had their parapets torn off, with detritus scattered on the land side, as shown in **Figure-20**. This indicates that the section collapsed because of spilling waves. It can also be seen in the photograph that there are pools of water on the rear side of the original position of the damaged section, which suggests that overflowing and scouring caused the damage. This idea is supported by the fact that no water was discovered on the rear side of the unaffected section. Because urgent restoration work was in progress when we visited the site and the damaged section was protected by sandbags, we could not confirm the damage that had occurred.

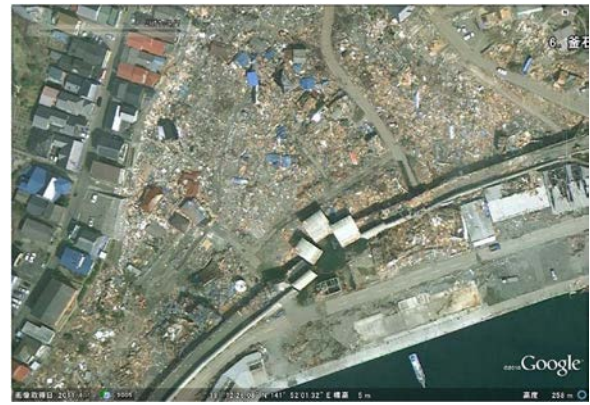
Figure-21 Aerial Photograph of Coast at Kojirahama Fishery Port (No. 7)

Figure-21 shows an aerial photograph of the coast at Kojirahama Fishery Port (No. 7) after the disaster. The total length of the tide wall in this area is 0.6 km. The four rectangular blocks in the center of the photograph indicate the location of the damaged section of the wall and the block positions show that the tide wall collapsed or leaned over toward the land side. The damage is shown in Figure-22. The soil at the rear side of the collapsed tide wall has

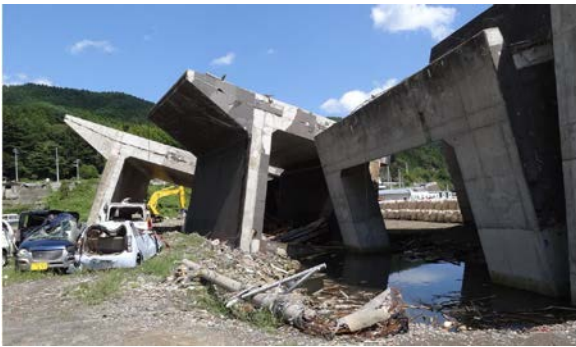
Figure-22 Damage to Tide Wall (No. 7)

largely been scoured and pools of water can be observed. Here again, the scouring is believed to be the reason for the collapse.

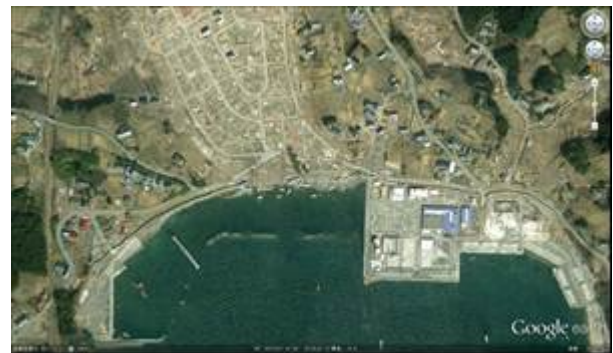
Figure-23 Aerial Photograph of Coast at Kadonohama Fishery Port (No. 9)

An aerial photograph of the coast at Kadonohama Fishery Port Coast (No. 9) after the disaster is shown in Figure-23. The damage in this area is shown in Figure-24. The damaged section of the tide wall collapsed toward the sea side. The wall at the front of the photograph shows seaward collapse and that at the back indicates landward collapse with drifting toward the sea occurring. Some traces of scouring can be seen on the rear side of the tide wall in other sections saved from collapse, as shown in Figure-25. The main reason for the scouring is considered to be overflow by the tsunami, the situation also being the same in the collapsed section.
