# **Post Typhoon Morakot Disaster Railway Reconstruction**

Zhang Shuang Gui , Su Jie Ting  
Kaohsiung Engineering Section  
Taiwan Railway Administration

## **Abstract**

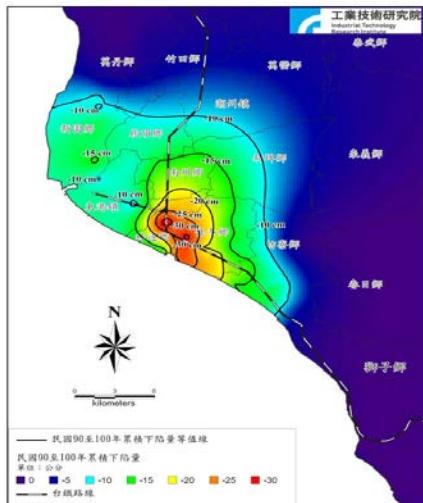
TRA Linbian River Bridge is located at K54+790 of Pintung Line. The bridge is 413 m long and is 1 km away from the estuary. It is a non-electrified single line 60-year old steel bridge. Linbian River is a typical silt-depositing river. In this area, there are dense aquaculture farms and they need fresh water supply and the water is supplied by pumping underground water and it led to the subsidence of land. According to statistical data, the land surface has been sunk for 3.76 meters since 1971. (Fig. 1)

(Fig. 1) Accumulated subsidence of land in Pintung Area between 2001 and 2011.

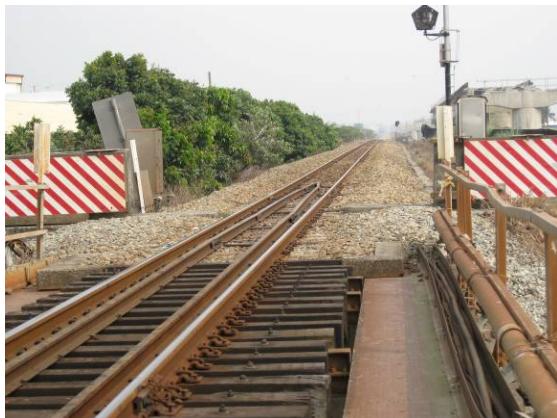
However, due to short of fund, it was unable to rebuilt in time and the south and north dykes had to reserve gaps (1.2 m high and 6 m wide) for the rail traffic (Fig. 4). In order to prevent flooding through the gaps during high water level of tidal period or invasion of typhoon with heavy rainfall, TRA built water gates to both gaps in Aug. 1995 as an emergency measure, so that the traffic safety may be maintained. As to the reconstruction project, Railway Reconstruction Bureau has contracted the project to contractors in serial to build a new bridge at about 12 m downstream of the existing bridge for a dual track most update standard electrified railway. (Fig. 5)

(Fig. 4) Old Water Gate of Linbian River Bridge  
Dyke Gap

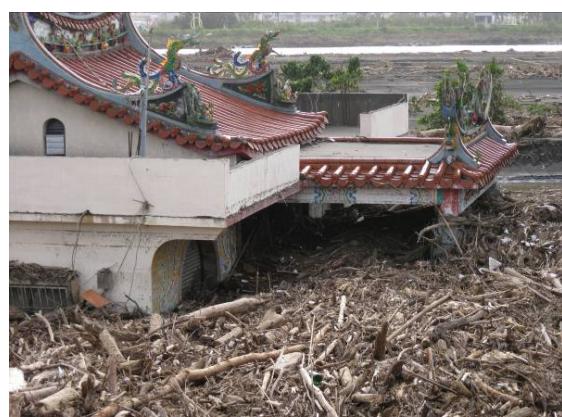
(Fig. 6) The water level is as high as to the 2<sup>nd</sup> floor and muddy water is flowing everywhere.

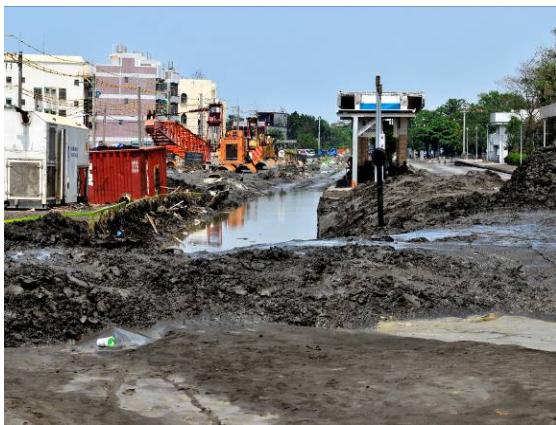
(Fig. 7) The height of deposited soil in Linbian Railway Station was almost as high as the platform.

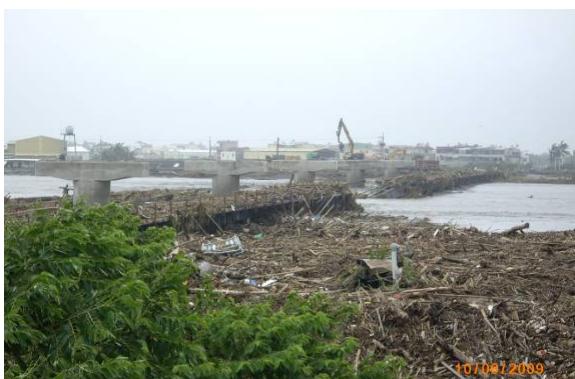
Due to the changes in the environment and terrain, the distance between surface of water flowing area and the bottom of Linbian River Railway Bridge was only 2 meter. With the instant heavy water flow, the cross section that allows for water to travel became insufficient, added with volume drifting wood (Fig. 8), furniture, bamboo rafts blocked by steel beam of the bridge. Under the giant thrust, the bridge was unable to sustain and 2 piers and 3 spans (P10, P11 & P12) were washed down (Fig. 9).

(Fig. 8) Volume driftwood brought up from upstream

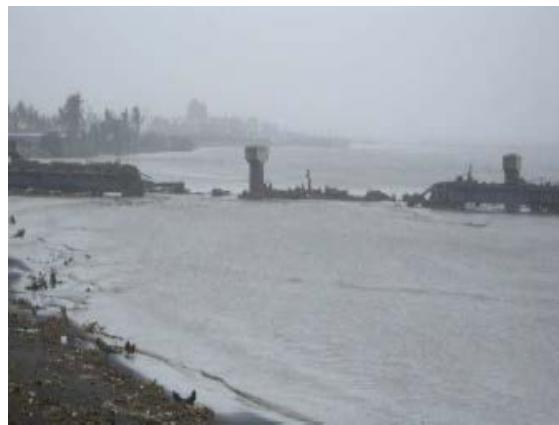
(Fig. 9) Washed off 2 piers and 3 spans (P10/11/12)

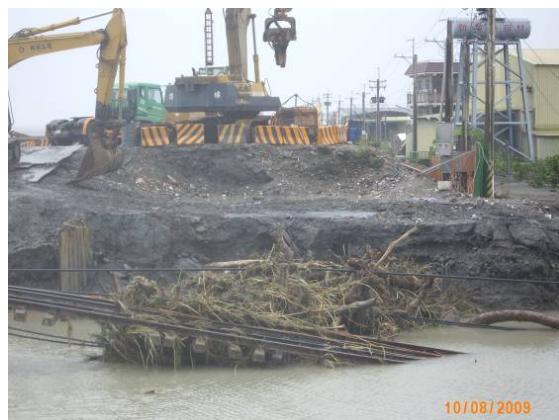
The upstream dike of north abutment was smashed for 30 meters and road base was flown away for 120 meters. In south side, the road base was covered by mud for 50 meters and the railway traffic was interrupted (Fig. 10).

(Fig.10) Damages to north abutment 、Washed off Road Base.

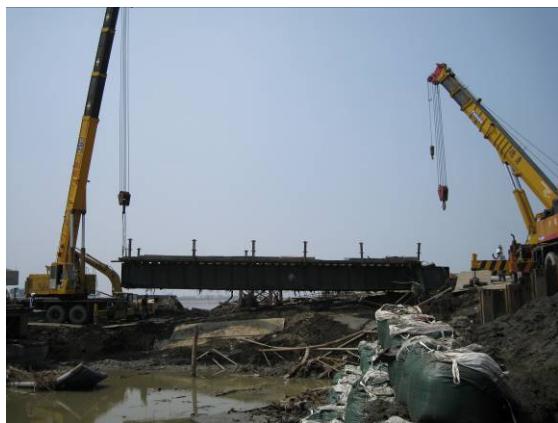
(Fig. 11) Bridge Steel Beams are totally lifted and moved away from site

- (1) Dismantle of Linbian River Railway Bridge Beams: After emergency joint survey of Aug. 27, to avoid added damages of any further invasion of typhoon, TRA removed all remaining 19 sets of steel beam of the bridge on

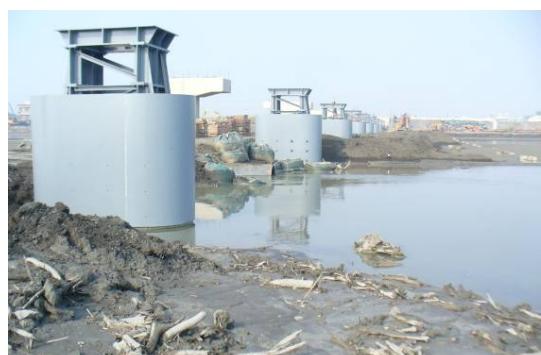
(Fig. 13) Adding 2 M high formed steel structure on top of pier and the RC piers are clad with steel plate and constrained with concrete.

(3) Raising Pier Height: Since the Linbian River Railway Bridge is lower than the dikes and the New Linbian River Railway Bridge, which is under construction and is scheduled to open to traffic by Dec. 2011 and there are still 2 high water period, and in order to increase the traveling section and eliminate break, the bridge is planned to raise up for 2 meters, after taking the slope restriction of railroad, the safety of pier structure and the traffic facilities of the surrounding area. The Project had price negotiation on Sept. 14, 2009 and commenced site construction. [On Sept. 3, 2009, Ceci Engineering Consultant, Inc. Taiwan was commissioned to design the 2-M pier height raising. The emergency raising budget was passed and job was contracted out on Sept. 14 with commencement on Sept. 15. The construction period was allowed for 115 calendar days (Phase 1 is 85 calendar days, with Dec. 30, 2009 targeted for opening to traffic; Phase 2: 30 days for dismantle of construction temporary bridge). A 2-M high formed steel structure is added to the top of each pier (total 20 sets); each pier is clad with steel plate and restrained with concrete. (Fig. 13)]

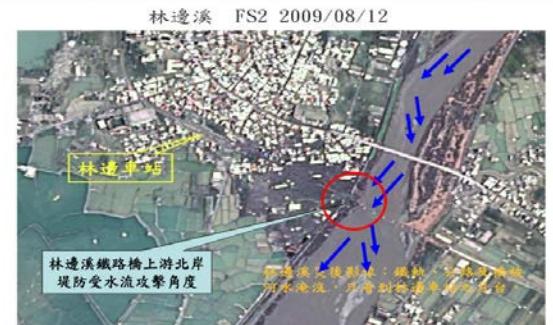
- 1) The rainfall on the day Typhoon Morakot hit Taiwan was indeed excessive and was in excess of 200-year frequency precipitation.
- 2) The S-curved flow of Linbian River offered different hitting angles and with the volume flood, along the river, from upstream to downstream, dikes were broken at many places. (Fig. 14)

(Fig. 14) Linbian River hitting angles.

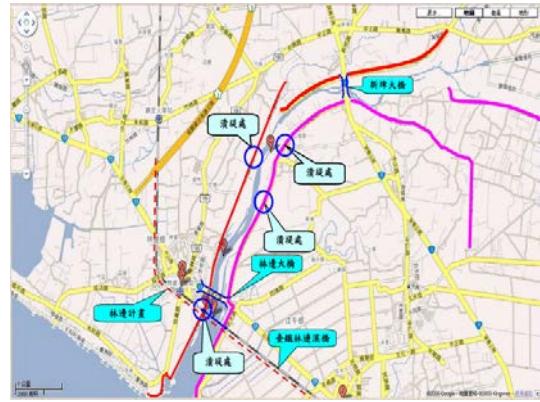
- (4) The lower part of the river water is characterized with S-shape flow and the attacking angles are curved and water flow rushes to and from. This is why the dikes were broken in many places both upstream and downstream and the break was not limited to the railway bridge. (Fig. 15)

(Fig. 15) Broken dikes along the river found after the disaster. (3 at upstream)

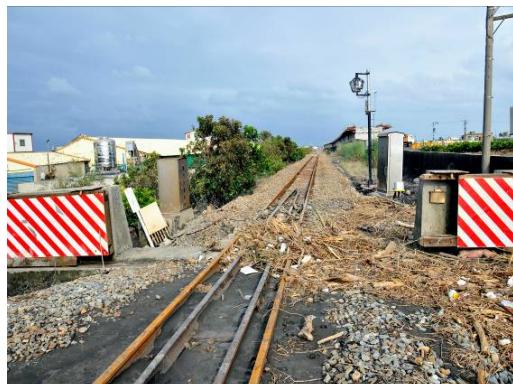
- (5) Height of dikes at both ends of Railway Bridge: The dike at the north side of Linbian River is about 0.9 m higher than the south side. Based on the fact that no effluent found at south bank, there should not be any in north Bank .(Fig.16)

(Fig. 16) South side gate was intact after the disaster due to deposit and stacking of drifting articles brought by the flood.
