Provincial Highway No.17 Shuangyuan Bridge Reconstruction Project

Ping-Hsun Huang*, Chi-Heng Chiang*, Hung-Ming Wu*, Yeong-Jong Liaw *
CECI Engineering Consultants, Inc., Taiwan*

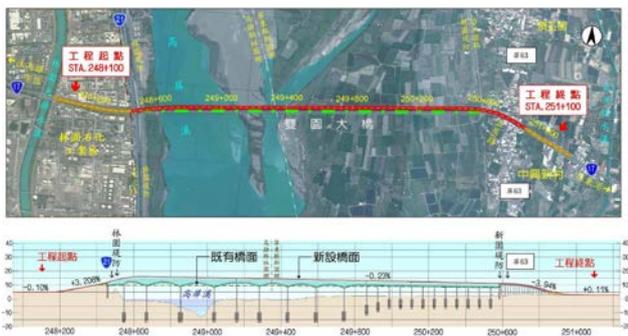
Option One: upstream side, completely deviates from the old bridge to locate the new bridge, as shown in Figure 2.

Figure 2 Option one layout, full offset from old bridge

A comparative assessment and evaluation of the options had been carried out, and decision was made to build new bridge at the upstream side of the old bridge. The two rehabilitation schemes are compared in Table 1. The Client selected option one for the final design scheme.

Items	Option 1 (full offset)	Option 2 (partial offset)
Alignment	Curve radius: Kaohsiung Linyuan end, R=600m and R=900m. Pingtung Xing end, R=500m.	Curve radius: Kaohsiung Linyuan end, R=950m. Pingtung Xing end, R=400m.
Widen for insufficient sight distance	1. Vd=80km/hr : Pingtung Xingyuan side R=500m to Kaohsiung, inner shoulder need to widen 1m. 2. Vd=70km/hr : Pingtung Xingyuan side R=500m to Kaohsiung, inner shoulder no need to widen.	1. Vd=80km/hr : Pingtung Xingyuan side R=400m to Kaohsiung, inner shoulder need to widen 2m. 2. Vd=60km/hr : Pingtung Xingyuan side R=400m to Kaohsiung, inner shoulder no need to widen.
New road of right (including river land)	New road of right approximate 54,665 m ² , no need for change of urban plan, Pingtung Xingyuan side uses more land.	New road of right approximate 44,660m ² , no need for change of urban plan, Pingtung Xingyuan side uses less land.
Construction Difficult	Upstream side for new bridge, fully offset from old bridge, easy to construct	Overlapping part of old bridge, difficult to construct

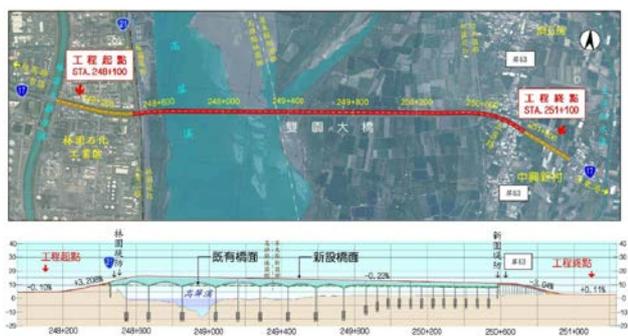
Option Two: upstream side, partially deviates from the old bridge to locate the new bridge, as shown in Figure 3.

Figure 3 Option two layout, partial offset from old bridge

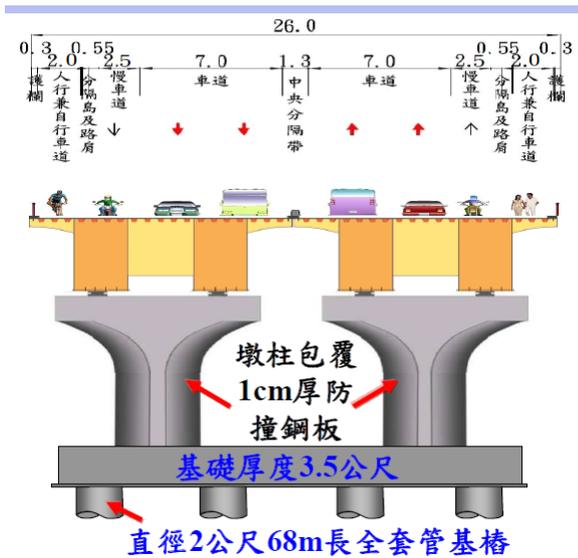
The project had to be completed before the deadline. Since the deep trench region across the bridge is about 1,200m. It is impossible to avoid flood season during construction. The superstructure and substructure should be built at the same time to shorten the construction time. For increased span length and lightweight, reducing the number of piers and the number of foundation piles, the steel box girder is selected. The main bridge section is 26m in width, and bridge height is about 16m. There are two steel box for superstructure, the girder depth of 2.6 ~ 4.2m. Orthotropic steel deck and Guss asphalt concrete pavement are used. The span arrangement is 105 + 2@120 + 96 + 3(96+2@120+96) + 105 + 2@120 + 96 = 2,178m, and the substructure is 200cm ϕ cast-in-place with full casing RC piles. The cross section is shown in Figure 4.

Figure 4 Cross section of main bridge

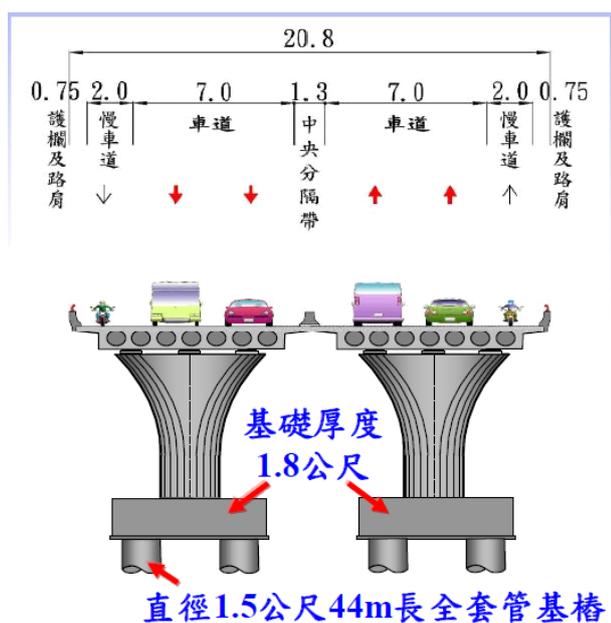
The span arrangement of approach bridge is $(26+30) + 2(3@31) = 242\text{m}$. Due to the existing bridge span arrangement and girder depth limit, the prestressed hollow plate girder bridge is adopted for superstructure (ground staging method), with girder depth of 1.2m. And the substructure is 150cm ϕ cast-in-place with full casing RC pile. The cross section is shown in detail in Figure 5.

Figure 5 Cross section of approach bridge
