# DAMAGE OF BRIDGE STRUCTURES BY HUGE TSUNAMI AND EVALUATION OF TSUNAMI FORCE ON BRIDGES

Kyuichi MARUYAMA\*, Yasushi TANAKA\*, Akira HOSODA\*\*  
Nagaoka University of Technology\*  
Yokohama National University\*\*

**KEYWORDS:** tsunami, damage of bridges, tsunami force

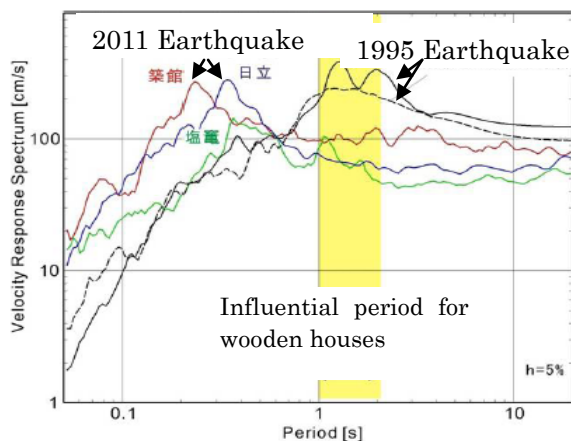
Fig.3 Comparison of velocity response Spectra (courtesy of Univ. of Tokyo)

As is already known the historically largest earthquake hit the eastern area of Japan on March 11, 2011. The moment magnitude of the earthquake is 9.0 which we have never had in our history of Japan. The characteristics of the earthquake lie in the wide range of fault moved with 500 km long in the north/south direction and 200 km wide in the east/west direction (Fig.1), and the long duration time of ground shaking in 2 or 3 minutes. In comparison with the Great Hanshin Earthquake in 1995, the duration time is about ten times long (Fig.2). The maximum velocity response spectrum looks similar but the predominant period is shorter as seen in Fig.3.

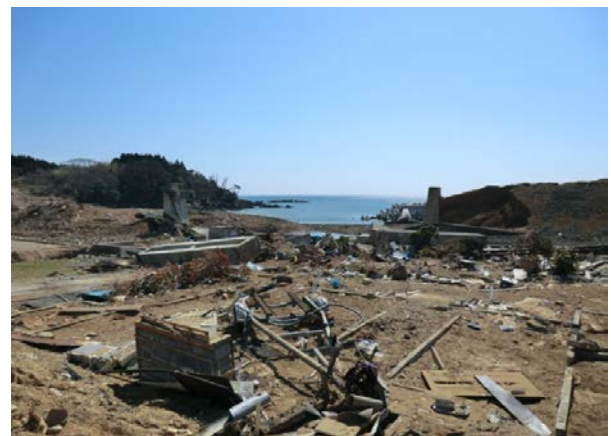
28 railway bridges were washed away by the tsunami. Figures 5 through 8 represent some cases of damage. Concrete girders were fallen down overturned near piers.

Fig.5 Washed away of concrete bridge

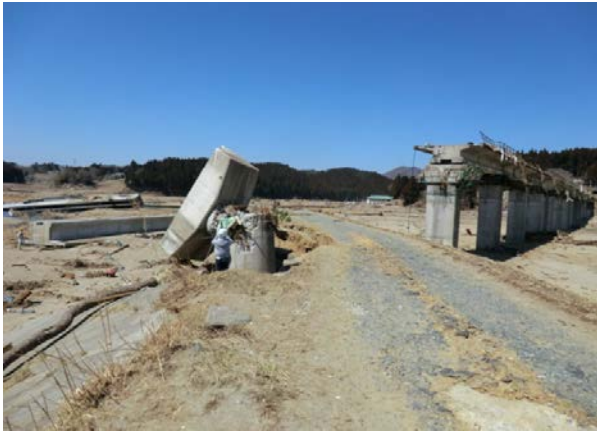
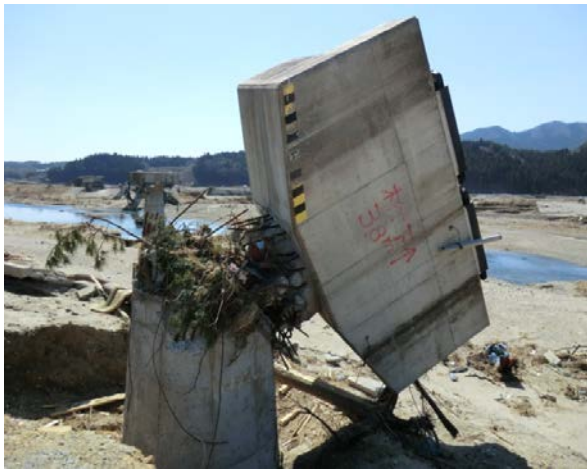
Fig.6 Broken pier at the top

Fig.7 Close-up view of broken pier

When special devices were installed on the top of pier to prevent the lateral movement of girder, the pier was broken out at the top by the bending moment produced due to tsunami force acting on the girders (Figs 6 and 7). Fig.8 shows the fallen prestressed concrete girder.

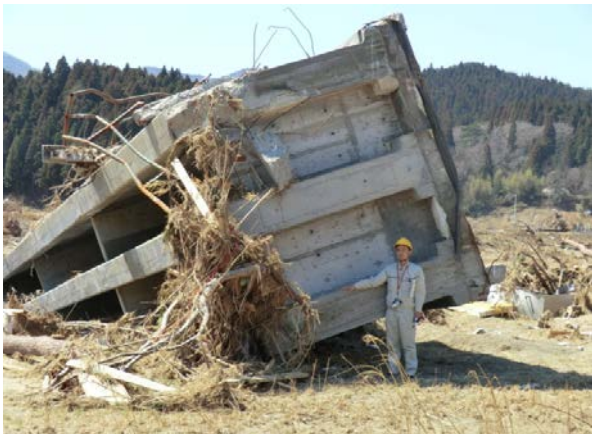
Fig.8 Fallen prestressed concrete girder

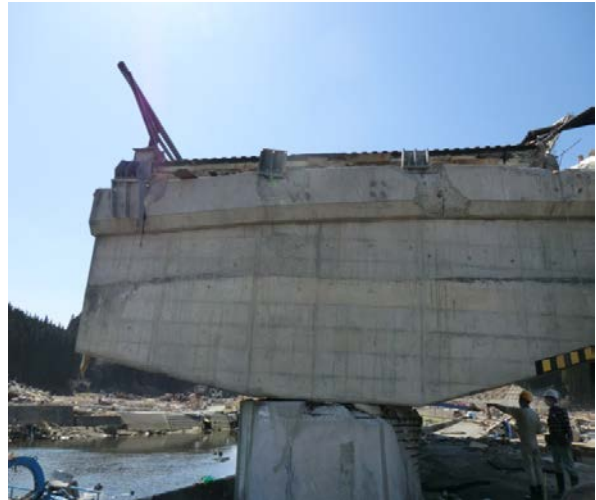
Road bridges also suffered from the tsunami (Figs 9 through 12). Devices to prevent fall down of girders during earthquake were useless against tsunami forces as shown in Figs 9 (broken devices for prestressed girders) and 11 (broken devices for steel girders).

Fig.9 Broken anti-fallen device

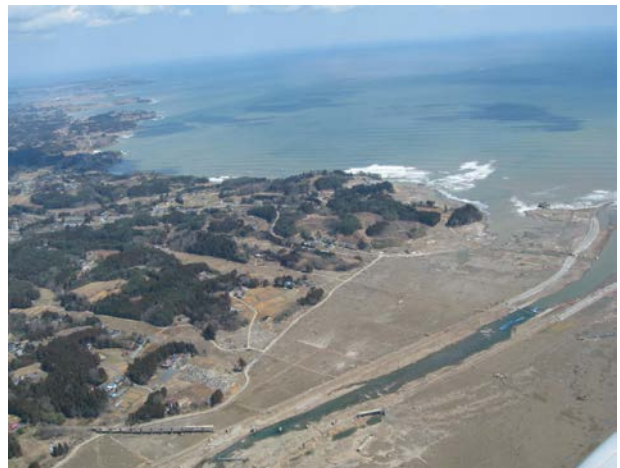
Fig.10 Bird's-eye view of Tsuya river

Fig.10 shows the bird's-eye view of Tsutani river area. Break water structures were completely collapsed. Both a road bridge near the mouth of the river and a railway bridge located upstream were washed away. A truss bridge had damage with two spans of truss member being washed away (Fig.12). The number of major road bridges washed away is 40.

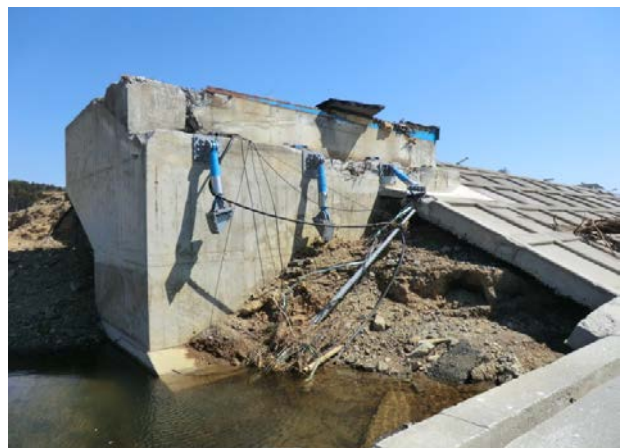
Fig.11 Broken anti-fallen device

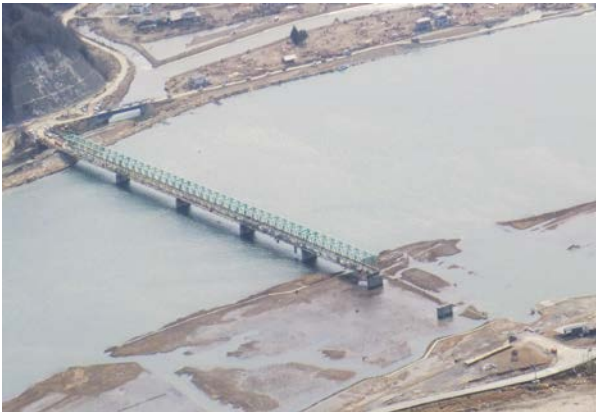
Fig.12 Truss bridge washed away

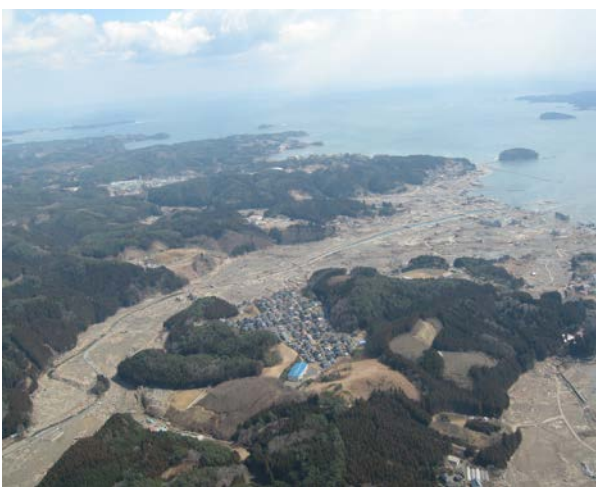
Although many bridges were washed away by the tsunami, many other bridges were survived. As is discussed in the later section, the ratio of washed away to survived is about 10%. It is not easy to see in Fig.13, but three road bridges are as they used to be. Figure 13 tells another feature that houses located at the higher hill side (seen at the middle portion of

Fig.13 Town attacked by tsunami

Fig.13) escaped from the tsunami disaster while a lot of wooden houses in the lower area were completely washed away.

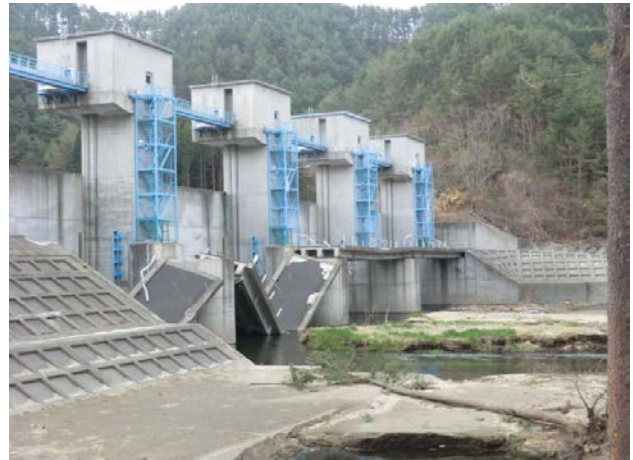
Fig.14 Broken decks next to water gate

Figure 14 shows a different type of damage of bridge decks. A certain amount of mass of water spilled over the water gate fell down and broke the pre-tensioned prestressed concrete bridge decks.

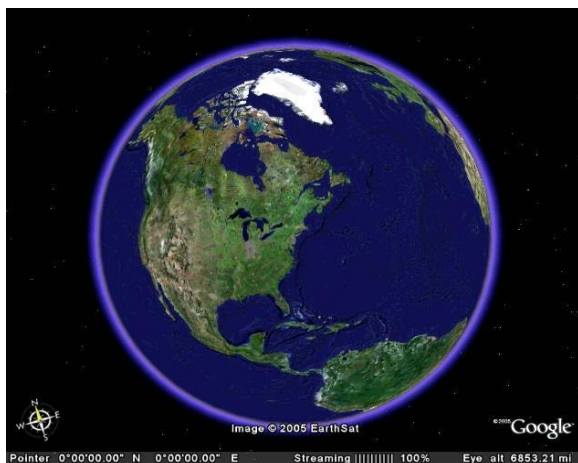
Fig.15 Internet image (Google earth pro)

The first target is to collect necessary information on bridges located in the inundation area by the tsunami. The internet is a powerful media for this purpose (Fig.15). Comparing pictures taken before with after March 11, 2011 as shown in Fig.16, the number of bridges washed away as well as that of survived ones was determined. Field survey has been conducted to confirm the details of bridges (Fig.17). The internet survey indicated that the total number of bridges to be surveyed was 3,230 and that the number of washed way bridges was 222, including 28 of railway bridge and 40 of major road bridge. With the field survey the rest were confirmed as small bridges owned by local governments.

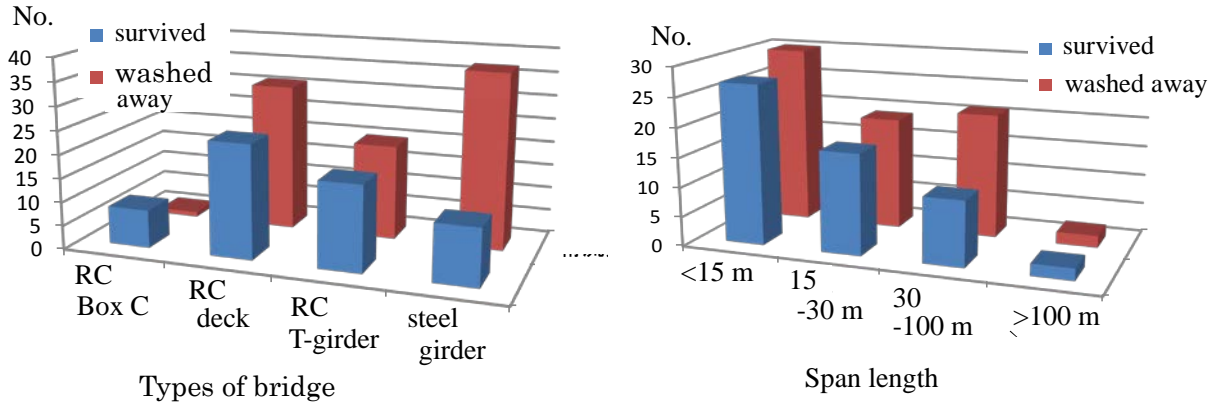
Fig. 18 Category of bridge

Fig.18 shows the number of bridges with or without suffering from washed away in comparison with categorized items, such as type of bridge and span length. In general, the total number of bridges survived in inundation areas is 1,703 while 222 bridges were washed away. In the figure only the survived bridges located near the washed away bridges are selected for comparison.

It is difficult to draw some tendency from Fig.18. This is because no consideration is taken for the velocity and the height of tsunami at the location of bridge. Then, in the next step the weight of girder and the horizontal force caused by tsunami are considered based on the equation proposed by Prof. Kosa. His equation is expressed as equation (1).

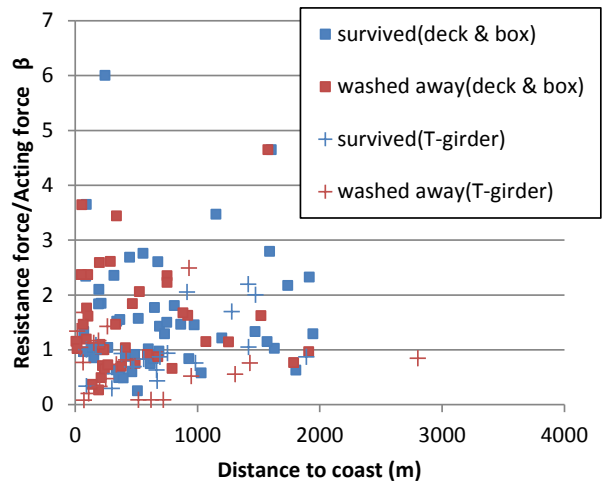
Fig.19 Cases of concrete girder

Figs.19 and 20 show the results for cases of concrete (RC and PC) girders and steel girders. Calculation of  $\beta$  was conducted for both bridges whose girders were washed away and whose survived. Blue and red marks represent girders survived and washed away, respectively. It is obvious that the equation (1) is not effective yet to evaluate the bridge behavior or tsunami force on bridges.

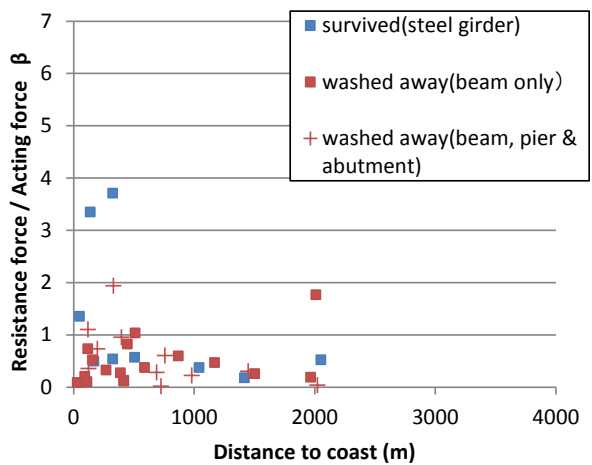
Fig.20 Cases of steel girder
