# Flood Investigation and Mitigation Strategies for Taipei City, the Role of Engineering Consultant Services after Flood Events

**Abstract:** This experience-based study aims at constructing a standard protocol, like “Flood investigation protocol, Norfolk Country Council, 2013” and “Flood investigations, Southampton City Council 2011”, for investigating flood schemes and setting guidelines for flood mitigation strategies in modern mega cities. Modern mega cities, such as Taipei City, are usually equipped with well-constructed drainage infrastructures. However, with the increasing frequency of extreme weather events, Taipei City is still threatened by flash flood during summer storms or typhoons. The major characteristic of flash flood in Taipei City is that it diminishes rapidly when the storm attenuates. However, the characteristic of flash flood in Taipei City also makes it difficult to reveal the major cause of the flooding events. Without clear evidence of the major cause of the flooding events, flood mitigation strategies may not be corrected drafted and the flood events will happen again during the next storm or typhoon. CECI engineering consultant incorporation has been ser

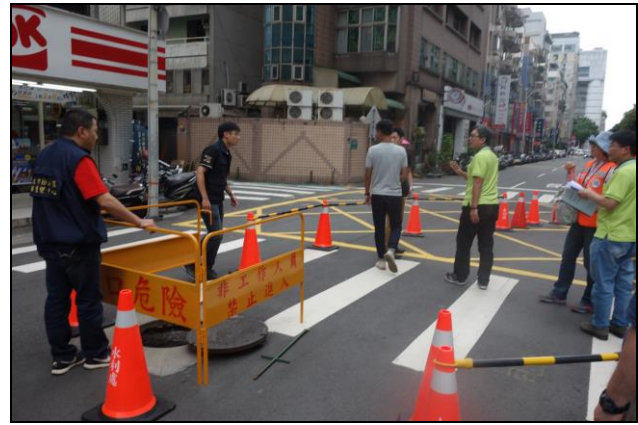
Photo 2.1 Traffic control during storm sewer system inspection.

When a flooding instance occurs, prior to the SWMM examination on the capacity of the sewer system, the function of the drainage systems, sewer systems and the pump stations' operational records must be inspected (See photo 2.1 to 2.3) to ensure that the drainage system functioned normally during the storm. The drainage systems are often choked by foreign objects such as fallen tree branches or building waste which was washed by overland flow. Moreover, pump stations may be ambushed by summer storms which change dramatically without significant warning. Therefore, the pump stations' operational records must be examined to clarify the responsibility and the cause of flooding instance.

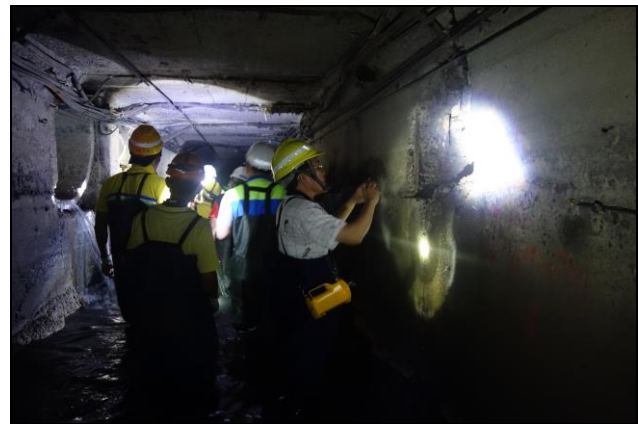
Photo 2.2 Storm sewer system inspection after a flooding instance.

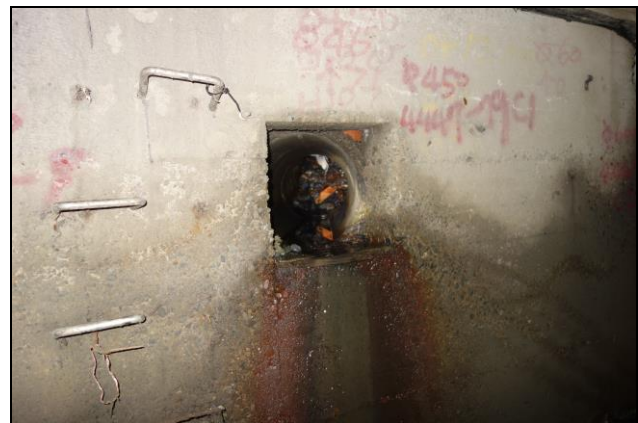
Photo 2.3 A choked pipe which has been marked with painting on the wall during storm sewer system inspection.

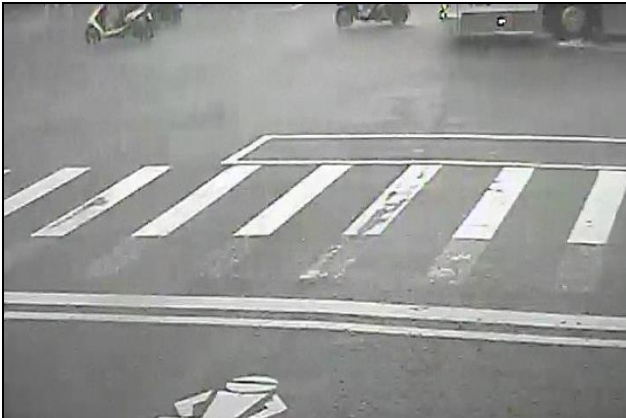
Photo 2.4 Monitoring camera record (before flooding).

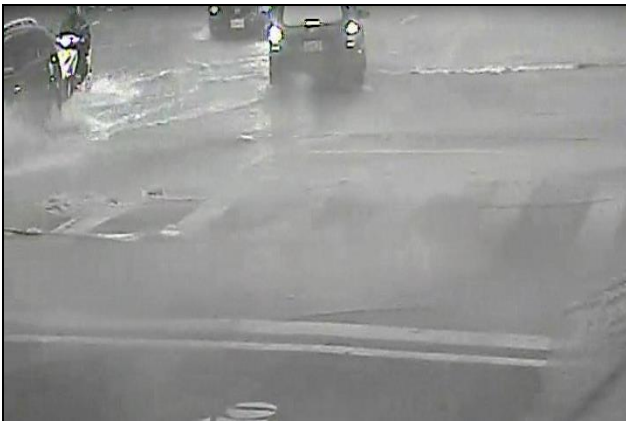
Photo 2.5 Monitoring camera record (during the flooding event on June 2<sup>nd</sup>, 2017).

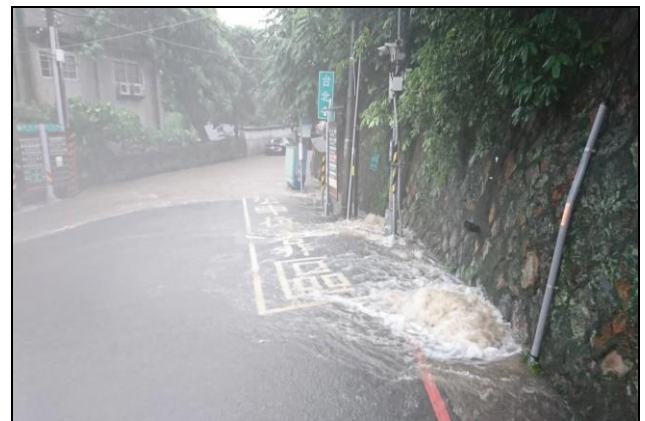
Photo 2.7 A precious flooding image provided by an enthusiastic flood victim.

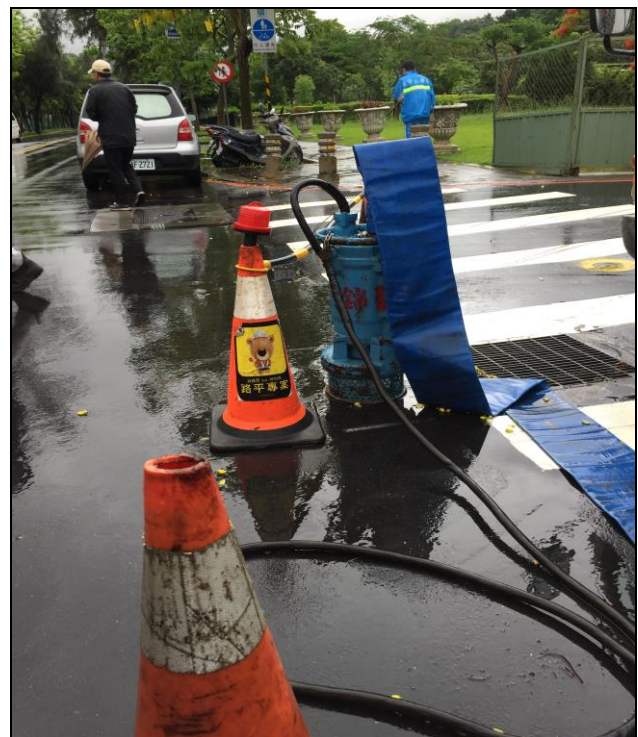
Photo 2.8 The deployment of mobile pump for assisting the capacity of the drainage system.

City are usually crowded with residents and cars and thus are difficult to expand the capacity of the storm sewer system. To mitigate the flood, we draft strategies of different stages. Considering that engineering procedures including detail design and constructions. Therefore, short term strategies are mobile pump deployment (photo 2.8) and early warning system to alert residents.

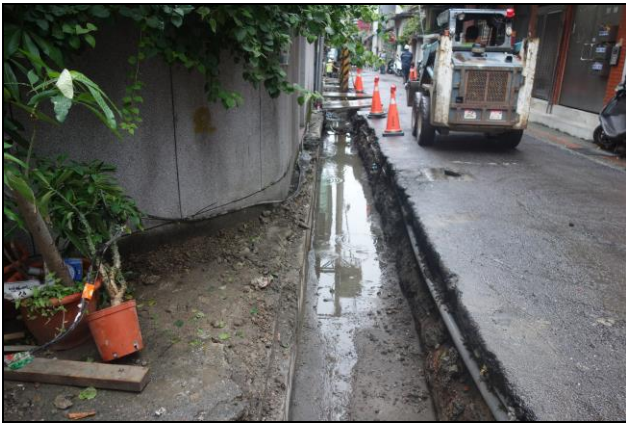
Photo 2.9 Ditch augmentation process to enlarge the capacity of the drainage system.

Flood events usually take place at where the storm sewer is relatively weak or the places with low surface elevation, the midterm strategy is to augment the sewer system till the whole sewer system meet the design standard. Moreover, the water at the relative low places should be detent at the parks with LID devices. The side ditches at the flooding area may be augmented to enlarge the capacity of the drainage system if it is necessary (photo 2.9).

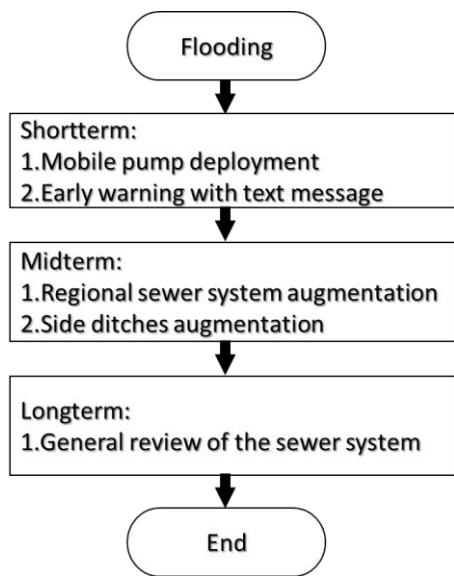
Figure 2.4 The flow chart for flood mitigation strategies.

Long term strategy is to review the sewer system generally with extra attention to the places where the storm sewer is relatively weak. The flow chart for flood mitigation strategies is drafted in figure 2.4.

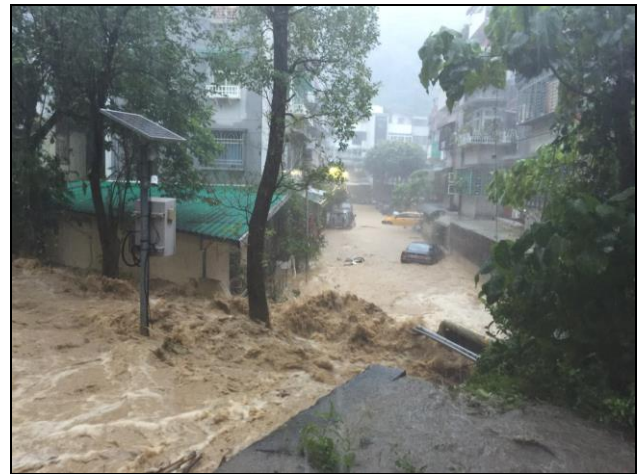
On June 2<sup>nd</sup>, 2017, a storm rain with intensity of 80.5mm/hour hit Neihu district and lead to a severe flooding instance (photo 3.1 and figure 3.2).

Photo 3.1 Flooding Schemes on June 2<sup>nd</sup>, 2017 at Neihu district.. .

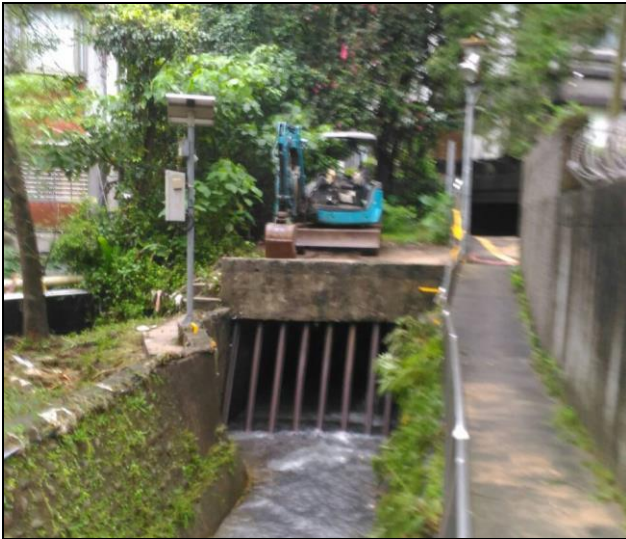
Following the investigation process shown in Figure 2.4, we investigated sewer system to check if it functioned normally during the storm, we found that the flooding was caused by a transition channel which connects silting basins and the sewer system and the channel overflowed during the storm (photo 3.2).

Photo 3.2 The transition channel and the entrance of the sewer system with trash racks at the opening.

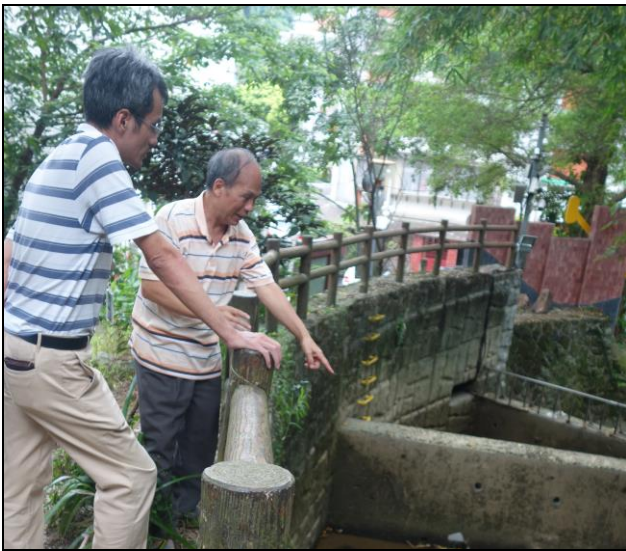
By interviewing the flooding victims (photo 3.3), we were told that trash and tree leafs choked the entrance and lead to the flooding event.

Photo 3.3 The transition channel and the entrance of the sewer system with trash racks at the opening

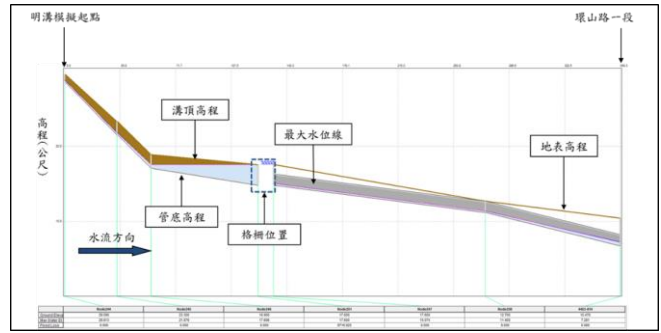
To clarify the cause of the flooding event, we utilized a SWMM to reproduce the flooding event with the recorded rainfall intensity (figure 3.3). We found that, though the rainfall intensity exceeded the design capacity of the sewer system, the sewer system should be able to drain the runoff without overflow. Therefore, the entrance of the sewer system choked by foreign objects is the major cause of the flooding event.

Figure 3.3 Reproducing the flooding event with a SWMM.
