SIGNIFICANCE OF VISUAL TEST AND HAMMERING TEST TO MANAGE CONCRETE STRUCTURE DURABILITY

KEYWORDS: concrete, visual test, hammering test, inspection

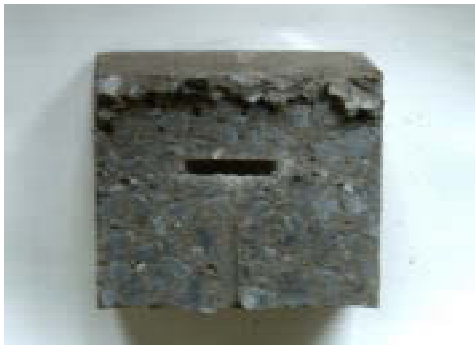
Specimens for 100 students to inspect defect in hardened concrete were rectangular specimens (L300×W150×D150) as shown in Fig.5 and Fig.6. The concrete consisted of river sand and crushed stone. The void defect was performed by dissolving styrene foam in acetone, i.e. after concrete hardened, preplaced styrene foam at defect position was dissolved in acetone injected through straw set behind of specimens, and the solution was taken out.

Fig.6 Defect on photograph of cut section

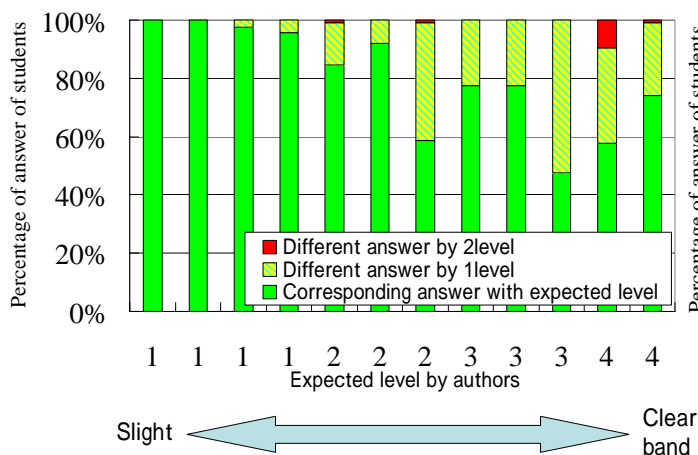
Fig.9 Result of visual test for Cold joint by 116 students (Before soaking NaCl solution)

The answers of students are almost corresponding with the expected answer by authors, as shown in Fig.9 and Fig.10, even when the specimens after soaking into NaCl solution were inspected. The percentage of corresponding answer in Fig.10 is more than that in Fig.9, because the inspection before soaking is a first experience for

student and the inspection after soaking is a second experience. Difference of level between the student's answers and the expected answers is almost under 1 level. But around boundary between two levels i.e. 1&2, 2&3, 3&4, percentage of perfectly corresponding answer is smaller a little.

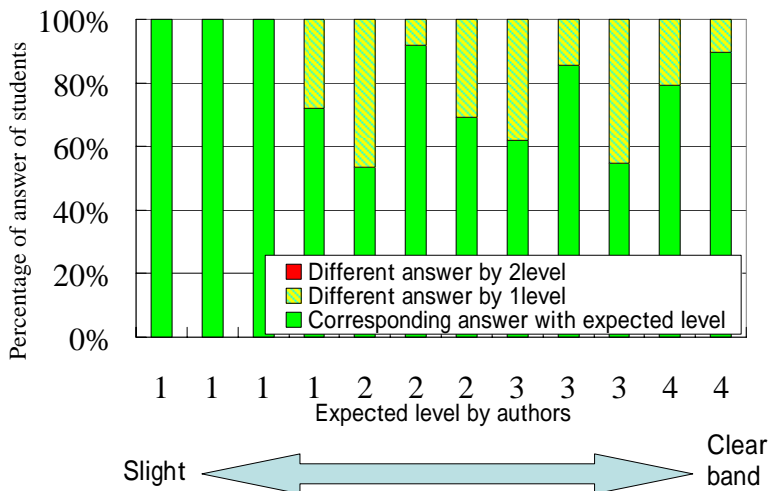
Fig.11 is a rewrite of Fig.10 based on the answers of 97 students except 19 students who gave up taking course unit of concrete experiment. All the difference is under 1 level.

Fig.11 Result of visual test for Cold joint by 97 earnest students (After soaking NaCl solution)

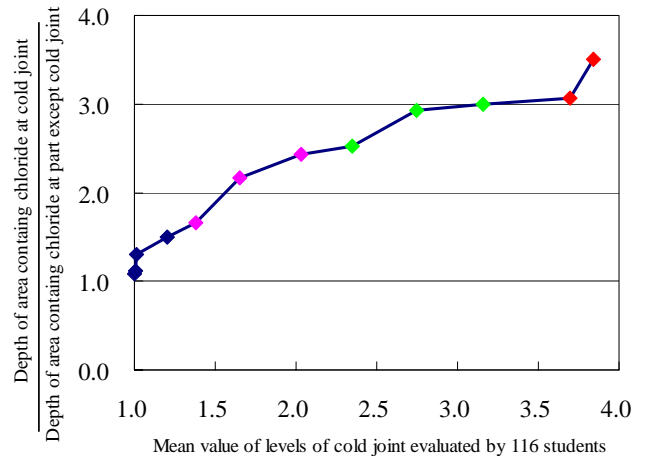
Relation between penetration of chloride and visual test result at cold joint is very close as shown in Fig.12. It is recognized that the larger the level of

Fig.12 Relation between result of visual test for Cold joint and depth of area containing chloride

cold joint observed by visual test, the deeper the chloride penetration. This tendency will be useful to estimate the diffusion coefficient of chloride ion at cold joint based on the visual test result, so that the depth of chloride penetration can be predicted with the estimated diffusion coefficient of chloride ion according to Japan Society of Civil Engineers standard specification. As the worst level of evaluation was limited, near of level 4 the plotted line is inclined sharply.

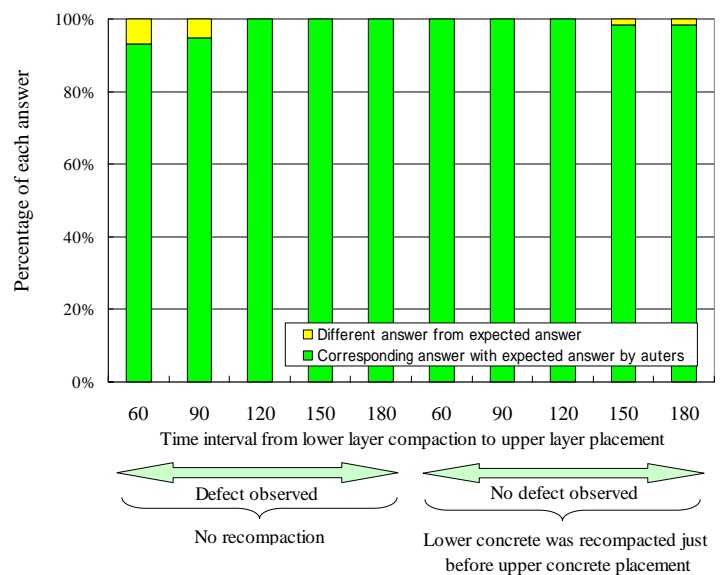
The answers of students are almost corresponding with the expected answer by authors, as shown in Fig.13. When the upper surface of lower concrete is significantly soft just before upper concrete placement because of short interval from upper layer placement to lower layer placement or adjusting bleeding water after recompaction, there are a few different answers.

Fig.13 Result of visual test for Sand Streak

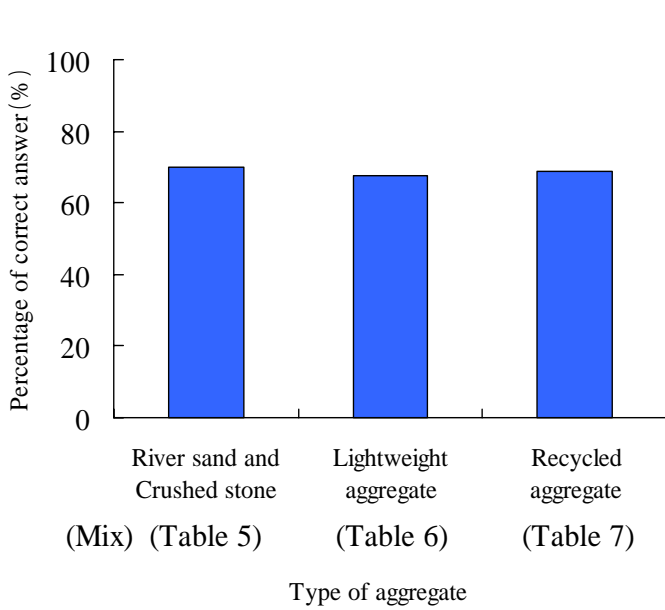
Fig.16 shows percentage of absolutely correct answer among concrete specimens of 5 strengths consisting of each aggregate (mix is shown Table5, 6

Fig.16 Effect of each aggregate on percentage of answer perfectly predicting the order of concrete strength between 5 concrete specimens

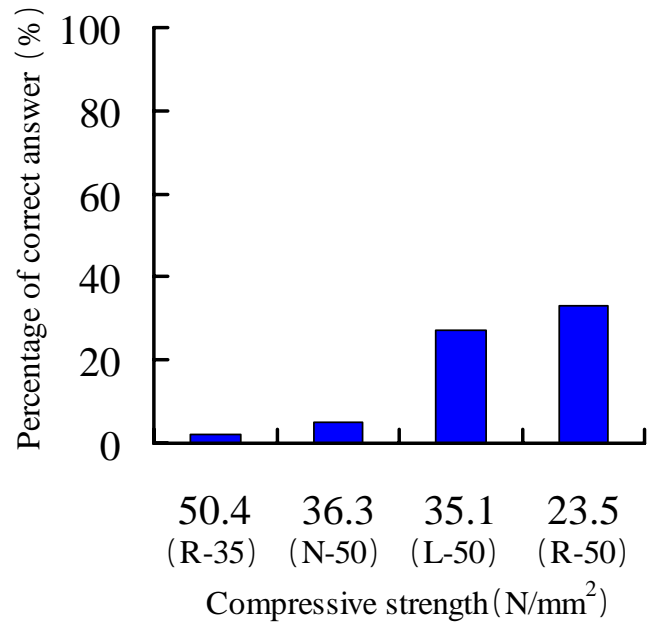
Fig.17 Relation between correct answer and compressive strength of concrete consisting of different aggregate

and 7). However when different aggregate concrete (mix N-50, L-50, R-35, R-50 shown in Table 3, 5, 6 and 7) is inspected, percentage of correct answer is significantly small, as shown in Fig.17. In this case, student predicted for the strength of lightweight aggregate concrete to be smaller so that the correct

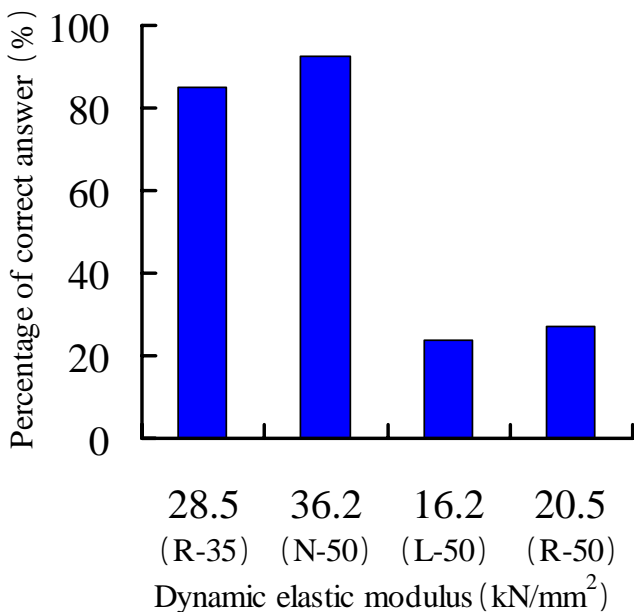
Fig.18 Rewritten result assuming hammering test inspects dynamic elastic modulus

answer for L-50 and R-50 is small. Assuming that the higher strength specimen predicted by student is the higher dynamic elastic modulus concrete, Fig.18 was drawn. Even if different aggregate concrete is inspected, the larger the dynamic elastic modulus, the larger the percentage of correct answer.

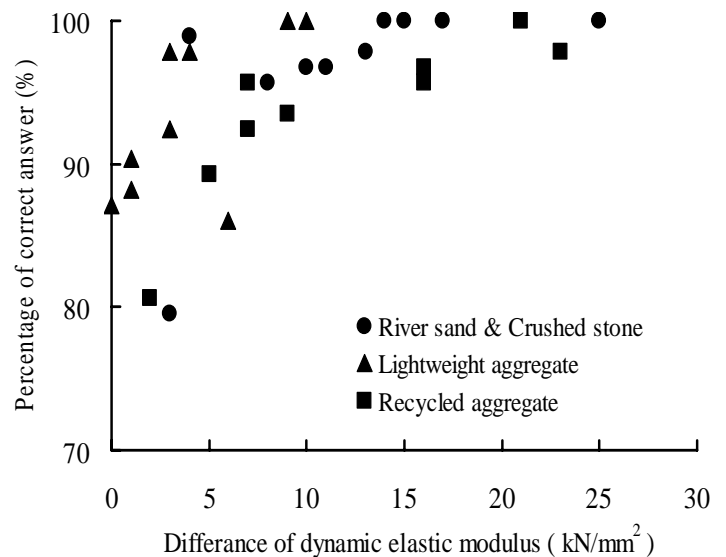
Fig.19 Relation between correct answer and difference of dynamic elastic modulus

Fig.19 shows relation between percentage of correct answer and difference of dynamic elastic modulus. Students more than 95% can correctly distinguish when the difference of dynamic elastic modulus is over 10kN/mm². The tendency that is “The larger the difference of dynamic elastic modulus, the larger the percentage of correct answer” can be considered to express that hammering test is for dynamic elastic modulus.
