Construction of the North-South-Metro Line in Cologne and the accident on March 3rd, 2009

Prof. Dr.-Ing. Alfred Haack
STUVA, Cologne, Germany
Former President of ITA

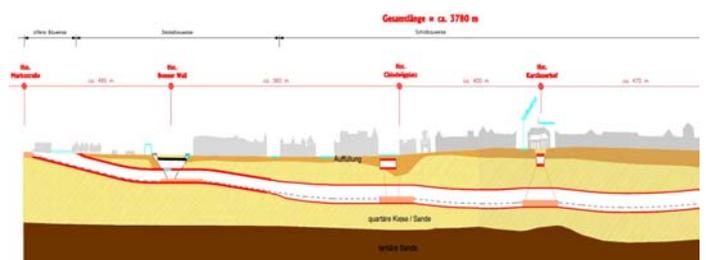
Figure 1. Southern section of alignment with 3 underground stations.

subterranean stations and one on the surface (figures 1-2). Towards this end, the projected tunnel route passes through major sections of the old Roman town – touching the former Roman port. It was reckoned that important archaeological finds will be discovered in the soil that had to be recovered and evaluated. Such digs have to be integrated in the construction cycle from the very beginning. The route then follows the former Roman north-south axis and runs along the Roman road connecting Cologne and Bonn through the medieval part of the city.

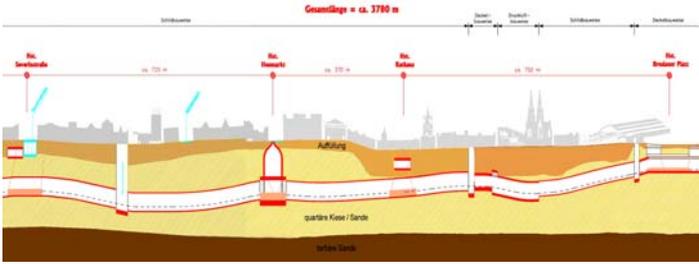
Figure 2. Northern section of alignment with 4 underground stations.

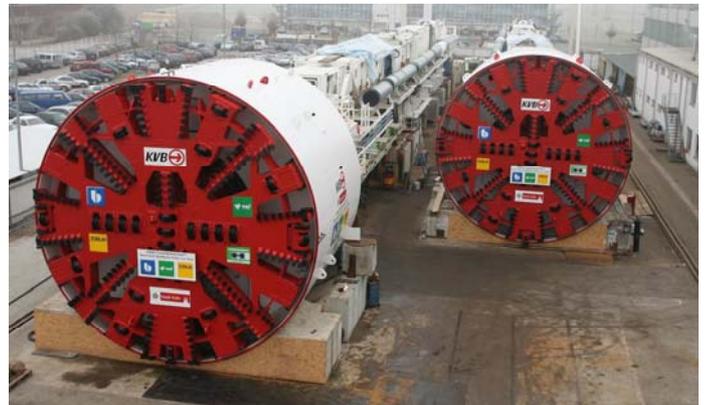
Figure 3. TBMs for southern section.

The two parallel single track running tunnels of the southern section with an internal diameter of 7.3 m were driven by mechanical means continuously from the starting shaft in the south to the target shaft in the north over a length of about 2.7 km using TBMs with an external diameter of 8.4 m (fig. 3). These were finished in summer 2008.

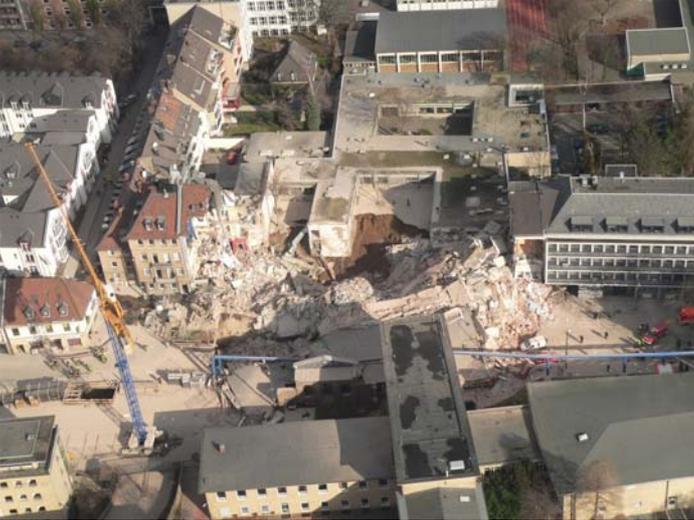
On 3rd of March 2009 during the final excavation work for the 28 m deep open pit of the Waidmarkt turn-off a catastrophic accident happened in the early afternoon. The seven storeys high Historical Archive of the City of Cologne collapsed including one neighbouring building on each side (fig. 4). This Historical Archive hosted 33 km of shelves containing numerous original documents, some older than 1200 years. These documents are covering the history of the City of Cologne but also of the surrounding Rhine area and partly also of entire Germany. Two fatalities were missing for a couple of days covered by masses of debris.

Figure 4. Aerial view of collapsed Historical Archive.

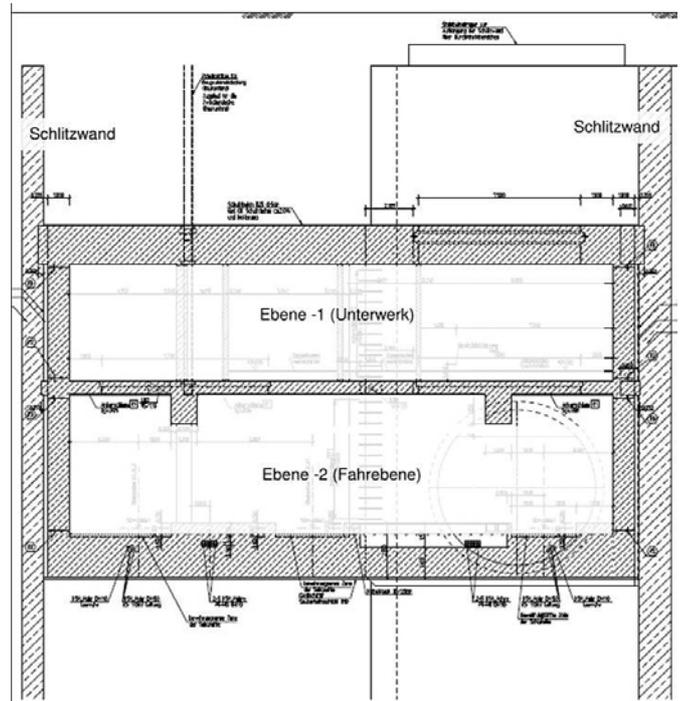
On the day of the accident the circumferential diaphragm-walls of the Waidmarkt pit were completely finalized and dived for at minimum 5 m into the less permeable tertiary ground formations underlying the sandy-gravelly quaternary coverlayers. The final depth reached about 45 m below surface. The excavation works inside the shaft had nearly reached the finally planned level of 28 m below surface. The sections of the pre-driven running tunnels inside the shaft were already rebuilt and the final as well as the intermediate ceilings were installed (fig. 5). Even the blinding concrete of the bottom slab was in some section already brought in.

Figure 5. Cross section of underground turn-off.

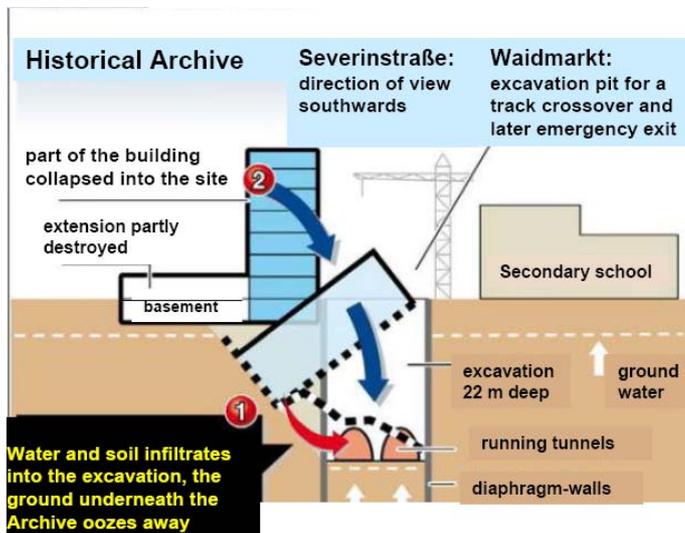
According to eye-witnesses about ten to fifteen minutes before the collapse of the Historical Archive an increasing inrush of water and later up to 5500 m³ ground materials started. This occurred in the south-east corner of the shaft either at the bottom of the excavation or penetrating the diaphragm-walls in their visible areas.

The accelerating infiltration of water and soil into the Waidmarkt shaft caused obviously a significant loss of ground underneath the Archive (fig. 6). This finally resulted in a cone of collapse outside the Waidmarkt shaft in which the Archive building collapsed. An idea of this situation is given by fig. 7.

Figure 6. Assumed cause of accident.

1. Immediately after the accident and the interruption of the ground water lowering a total of about 2900 m³ concrete was poured into the Waidmarkt shaft to balance the buoyancy and stabilize the situation.

2. In addition concrete barrier walls were erected in the connected 4 running tunnels to stop any propagation of a mixture of soil and ground water into the already completed northern and southern tunnel sections and underground stations.

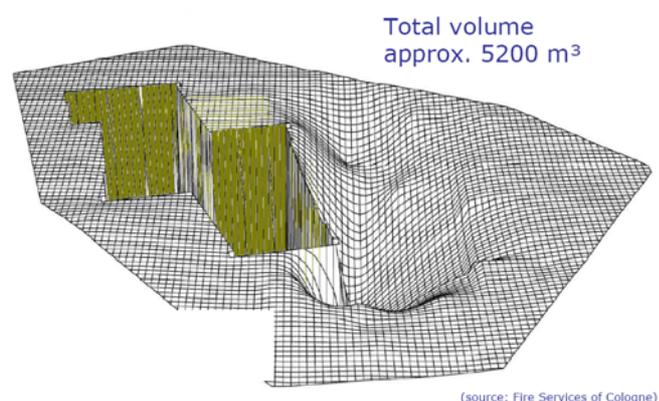
Figure 7. Assumed cone of collapse.
