Reconstruction of Provincial Highway No. 13 Hou-Feng Bridge Damaged by Typhoon Sinlaku

CECI Engineering Consultants, Inc., Taiwan*

ABSTRACT: Typhoon Sinlaku brought a heavy rainfall on September 14, 2008. The P2 pier of Houfeng bridge was washed away by rushed Tachia Hsi river water. It caused part of the bridge deck collapsed and the traffic from Houli and Fengyuan was interrupted at once. In order to resume the traffic as soon as possible, Directorate General of Highways, MOTC planned a rehabilitation strategy which was including short-term rehabilitation scheme adopting temporary access road, intermediate rehabilitation scheme using temporary access bridge and long-term rehabilitation scheme building permanent bridge. The main purpose of the plan was to reduce the social cost and improve the traffic safety in typhoon season.

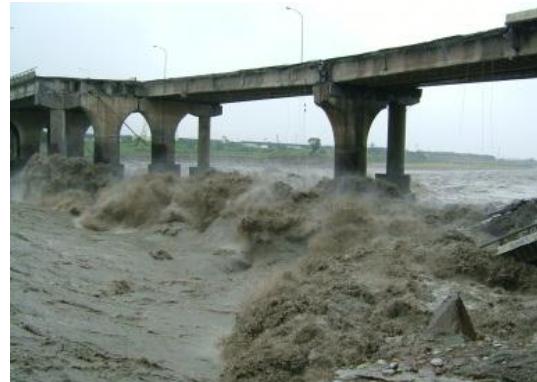
On September 12, 2008, during Typhoon Sinlaku invasion, it caused a serious disaster for Taiwan. From 12th 0:00am to 15th 8:00pm, according to the Central Weather Bureau record, there were 1,600 mm rainfall in Taichung County which was ranked as No.1 in Taiwan. The foundation of P2 pier of Houfeng bridge was void for scouring at around 7 pm on September 14, resulted in a bridge deck collapse in north bound lane. And the traffic was disrupted (Photo 1.1). Directorate General of Highways, MOTC immediately built an emergency temporary access road on the downstream side of the bridge site about 100 meters away to reconnect the traffic cross the river. Later on, an emergency temporary access bridge was constructed for the traffic demand. (Figure

Photo 1.2 Houfeng bridge collapsed in Typhoon Sinlaku

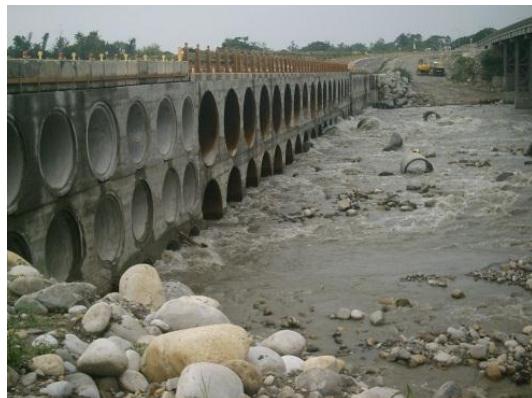
- (8) Cast-in-place reinforced concrete box culvert did not match the construction schedule requirements, so the main

components were using steel pipe and the market available RCP pipe. (Photo 2.1)

Photo 2.1 Temporary access road built by steel pipe and RCP pipe

15m long H-section steel piles were used for the temporary access road foundation to have sufficient anti-erosion capability. Steel pipe culvert and RCP pipe were adopted for easy construction and flood passing requirement. Although H-section steel piles and steel pipe culvert could be recycled, the initial cost was still high. For the flood concern, the diameter of existing RCP pipe

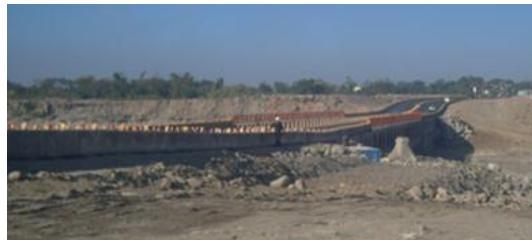
The old Houfeng bridge was interrupted on September 14, 2008, and the temporary access road started to construct on October 5. At the same year, the traffic was reopened on October 26. It took only 21 days to complete a 700 meters long and 15 meters wide, two-way four-lane temporary access road. (Photo 2.2)

Photo 2.2 Completed temporary access road

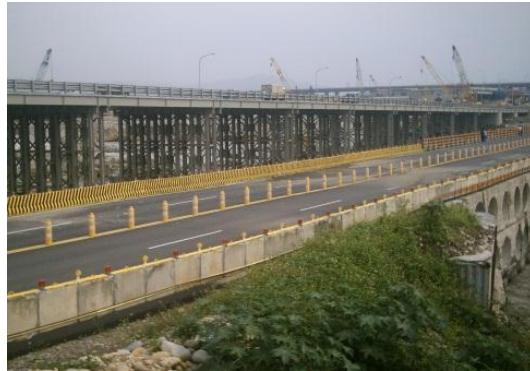
Temporary access bridge made in steel was started to constructed on October 15, 1997 and was completed by December 20 of the same year. It took only 66 days to

construct the 300 meters long and 15.5 meters wide, two-way four-lane steel bridge for 15 tons of heavy vehicle traffic. (Photo 3.1)

Photo 3.1 Completed temporary access bridge

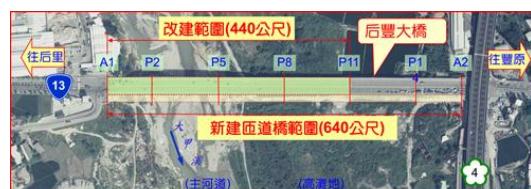
(1) The original plan was only 280m long reconstruction, P1~P6 pier, in the main river channel. However through a detailed hydraulic analysis, the original plan was not able to meet the needs of the flood control section. It was finally approved the alteration of 440m long reconstruction, P1~P10 pier, and additional ramp, P11~A2, in PCI girder. (Figure 4.1, 4.2)

Figure 4.1 Plan view of Hou-Feng Bridge

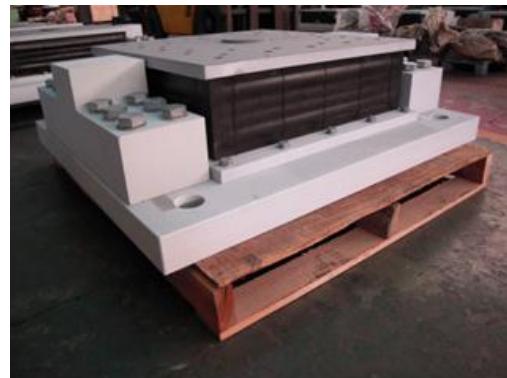
(4) In the seismic design, Houfeng bridge not only met the seismic design specification, but also used high damping rubber bearing (HDRB). (Photo 4.1) By using the HDRB the seismic force can be distributed to all the piers to reduce the impact of seismic forces on a bridge. Elasticmeric bearing support has three advantages: (a) the seismic force acting on each pier was reduced, so that bridges can be multi-span continuous; (b) under earthquake, the elasticmeric bearing can appropriately extend vibration period to reduce the seismic force; (c) by adjusting the horizontal stiffness of elasticmeric bearing, the level of force for each pier could be also adjusted. Moreover, the usage of high damping rubber bearing has three more advantages: (a) the normal horizontal force from elongation or shortening can be reduced; (b) less vibration caused by normal applied load (live load, wind load, etc.); (c) considerable energy absorption (damping) function can reduce the seismic force, effectively reduce the number of piles, the

size of the pile cap, project costs, construction time and the scouring.

Photo 4.1 High damping rubber bearing

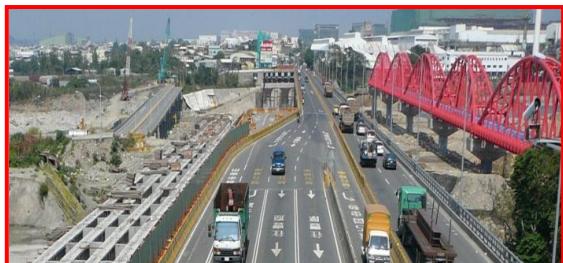
The main bridge construction was started on October 20, 2008. By all the effort, the first stage traffic was opened on

June 29, 2009. Only eight months of construction, 440 meters long, 15.5 meters wide, two-way four-lane steel box girder bridge was built and opened to service for all kind of vehicles.(Photo 4.2) The second stage was completed on July 23, 2001 for the remaining 440 meters long, 15.5 meters wide, four-lane steel bridge and 640 meters long, 10 meters wide, two-lane ramp. (Photo 4.3)

Photo 4.2 Serviced Houfeng ridge at first stage

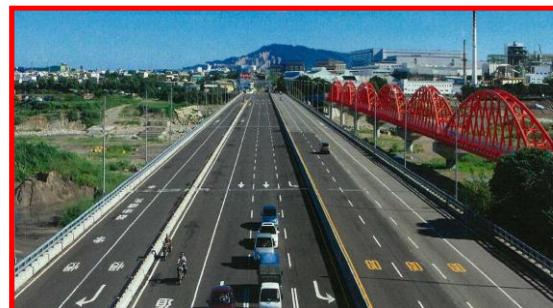
Photo 4.3 Completed Houfeng bridge

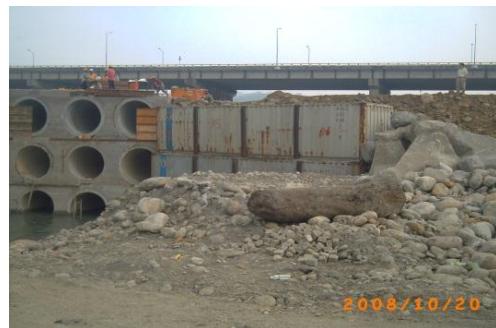
- The detour road at both ends of the embankment was not built in pile foundation. Containers were adopted for the reinforcement, and they were not able to prevent the flush-away by the flood. (Photo 5.1) However, there was no better method to avoid the problem for this section of detour road.

Photo 5.1 Container embankment

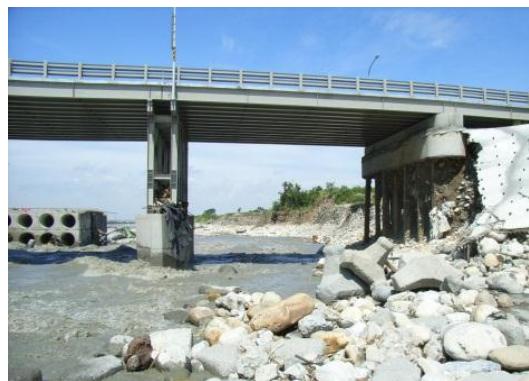
Since the flow of Tachia Hsi was so fast, H-section steel pile foundation was continued to be hollowed (Photo 5.2). Based on safety concern, during the typhoon the temporary steel bridge was needed to be closed. The advantages of temporary steel

bridge were no requirement to repair the road embankment sections, both sides of the road embankment sections were easily washed away after typhoon. The staff was under a tremendous pressure for bridge closure and tried to repair the road within a few days.

Photo 5.2 Temporary steel bridge with H-section steel pile
