The Reconstruction of the Processes of Compound Disasters in Siaolin Village Caused by the 2009 Typhoon Morakot

Huang Hsiao-Yu*, Yin Hsiao-Yuan*, Shieh Chjeng-Lun**, Lai Wen-Chi**

Disaster Prevention Research Center, National Cheng Kung University, Taiwan**

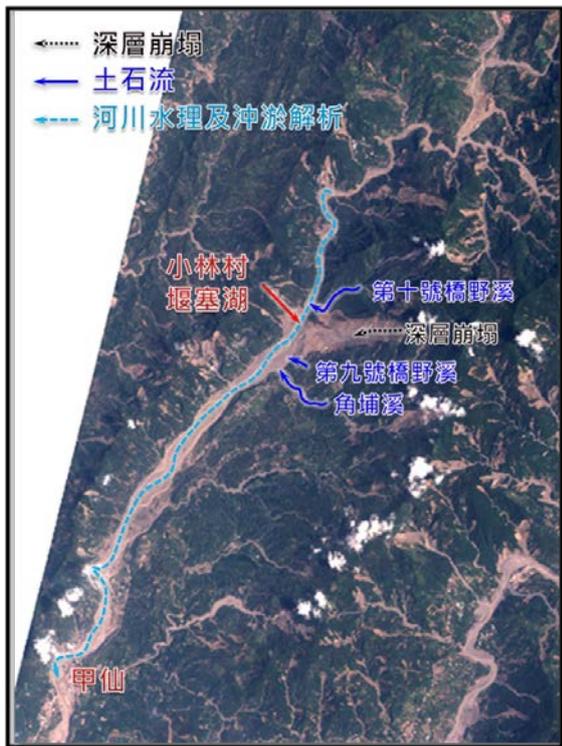
figure 1 study area (Siaolin Village)

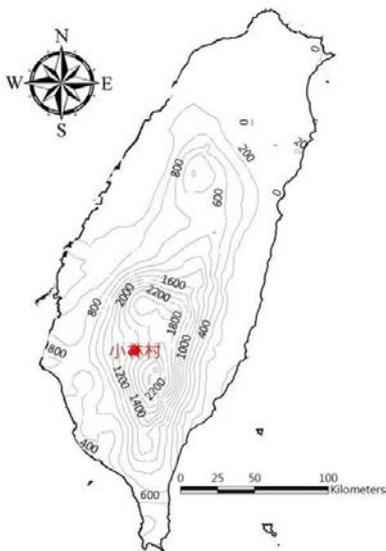
The Jiasian metrological station registered an accumulated rain amount of 1,911 mm (figure 2) and a maximal intensity of 94.5 mm/hr. Sediment mass due to triggered slope collapse blocked Cishan River and formed a natural dam. The continuously heavy rainfall leads finally to dam break. The village was flooded by sediment flow, leaving 398 people dead or missing.

figure 1 distribution of accumulated rainfall by Typhoon Morako

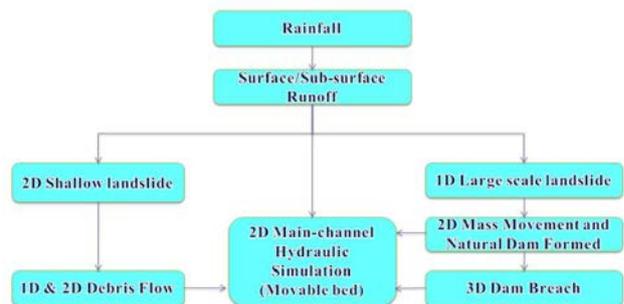
On the base of the results of field survey, numerical simulations were carried out to describe the sediment transport by Typhoon Morakot at Siaolin Village. Then the temporal and spatial order of the processes could be reconstructed. The study frame is shown in figure 3 and depicted briefly below.

figure 3 study frame

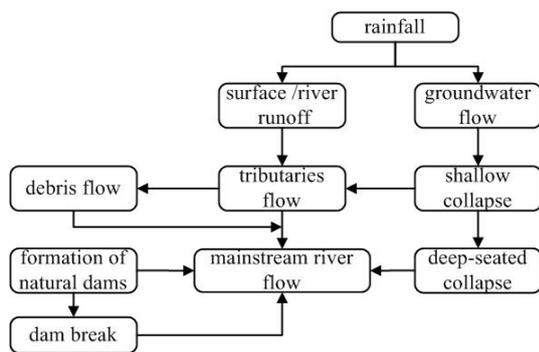
firstly to analyze its effect on infiltration. Simulation results provide the input information for landslide analysis. Results of landslide analysis are necessary to simulate debris flow because landslide is the main mechanism of sediment yield. Collapsed sediment could also block the flow to form natural dam. Landslide analysis is the initial step for further simulation of dam formation and dam break. The correlations of each analysis procedure are illustrated in figure 4.

figure 4 illustration of components and interfaces for compound disaster analysis

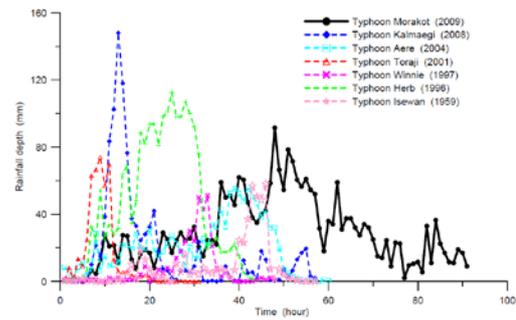
According to the recorded data of metrological stations, the rainfall hydrograph of Typhoon Morakot hat characteristics of high intensity, long duration, broad extent and large amount (figure 5 and 6). The figures show that the rainfall intensity of Typhoon Morakot remained high for 91 hours. The phenomena could explain the increase of landslide area of 36,000 ha, sediment yield of more than 1,000 million cubic meters and 14 natural dams. Showing the eyewitness report and rainfall hydrograph together (figure 7) a close correlation between the rainfall and each process is suggested. The preliminary reconstruction of the event serves as the base for further analysis and validation of numerical simulations.

figure 5 accumulated rainfall depth of selected typhoons

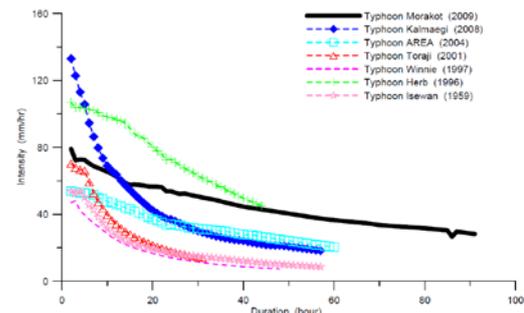
figure 6 Intensity-duration curves of the selected typhoons

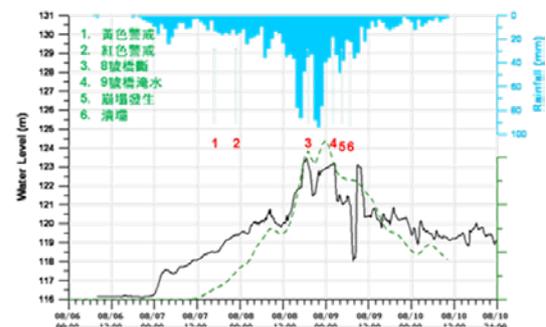
figure 7 a preliminary reconstruction of the event

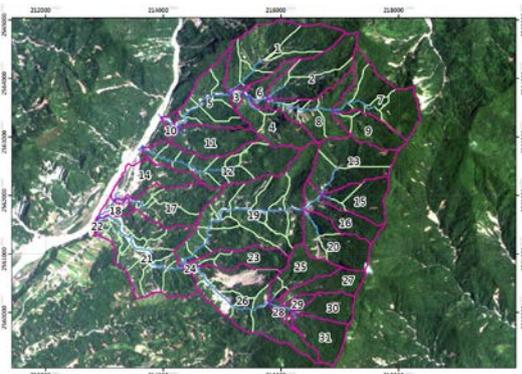
The analysis area is shown in figure 8. The area was divided into 31 units with a size of 100 m × 50 m. Coefficients are determined by satellite image processing, field survey and soil material test.

figure 8 analysis area of shallow landslide

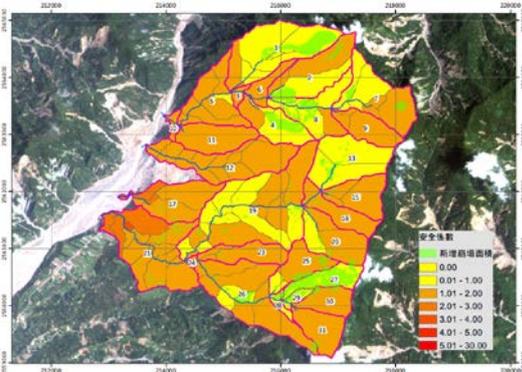
New landslide area is about 122 ha totally. That leads to a sediment yield of 3.8 million cubic meters. If the safety factor (SF) is defined as the ration of resistant force to drive force, then the distribution of landslide sites and safety factors in the survey area are illustrated in figure 9. The green color marked the landslide area. The change of the calculated safety factor suggest the time when landslide occurred. A landslide occurs if $SF < 1$ (ref. figure 10).

figure 9 analysis area of shallow landslide

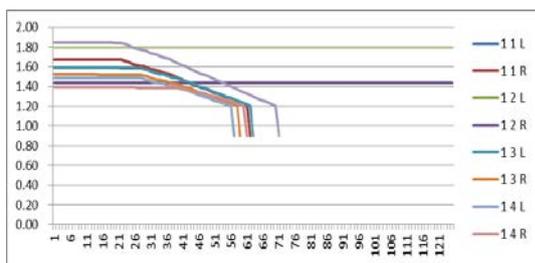
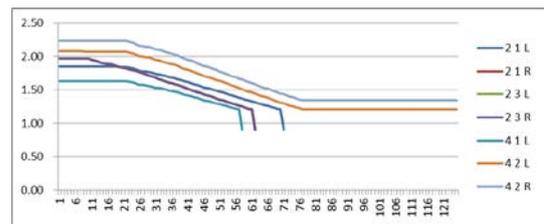
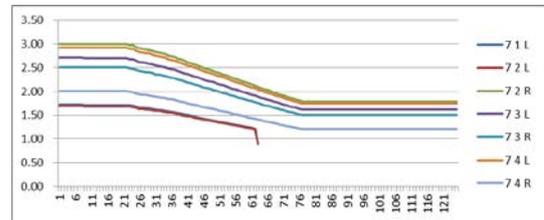
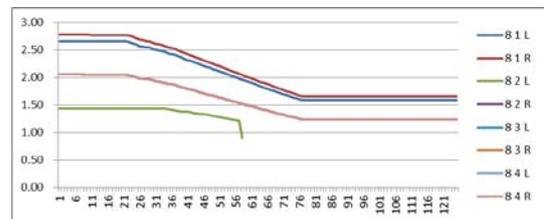
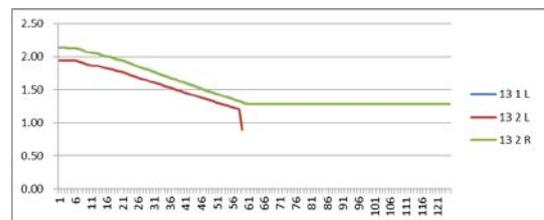
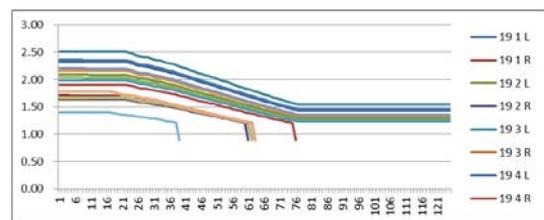
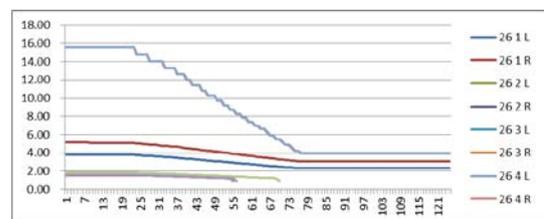
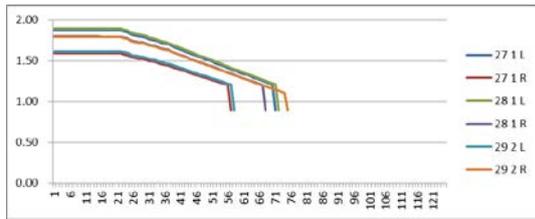
figure 10 temporal change of safety factors

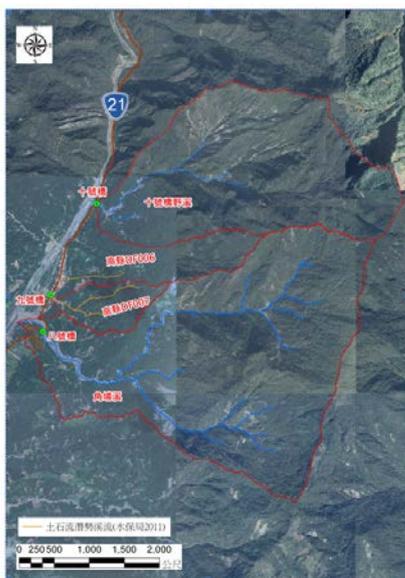
There are 4 debris flows in the survey area: creek at bridge no. 10, creek at bridge no. 10, Kaohsiung County DF006 and Kaohsiung County DF007 (figure 11). The sediment deposition fan were identified by making a comparison between the satellite image before and after Typhoon Morakot (figure 11 and 12). Then the related data were collected by evaluating 5m ×5m DTM, investigation and morphological survey including to calibrate the 2-d numerical model. Numerical simulations were carried out by using the calibrated Debris-2D model. The calculated changes of river bed of the 4 debris flows are shown in figure 13.

figure 11 location of debris flows in the surveyed area (before Typhoon Morakot)

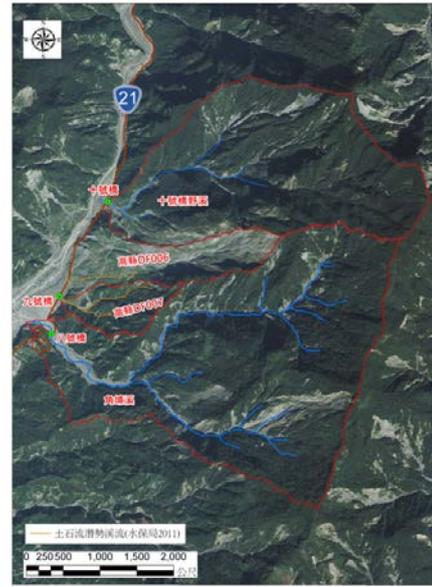
figure 12 the stand of debris flows after Typhoon Morakot

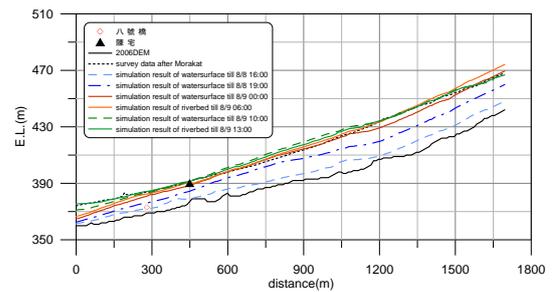
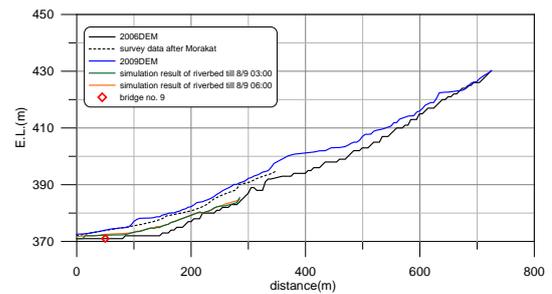
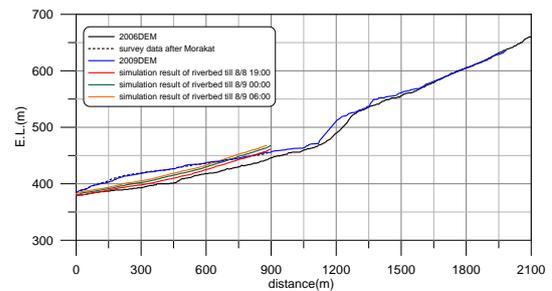
figure 12 simulation results of river bed changes

The simulation results are approximated to the survey results and eyewitness report. It also suggests that the debris flow was a continuous process by Typhoon Morakot.

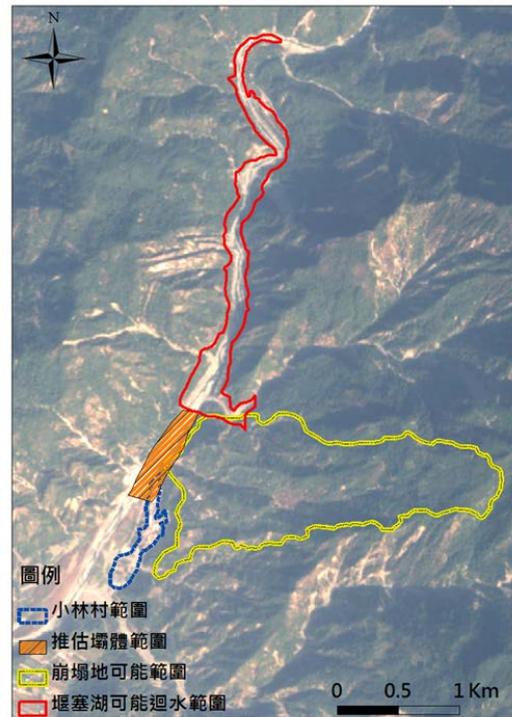
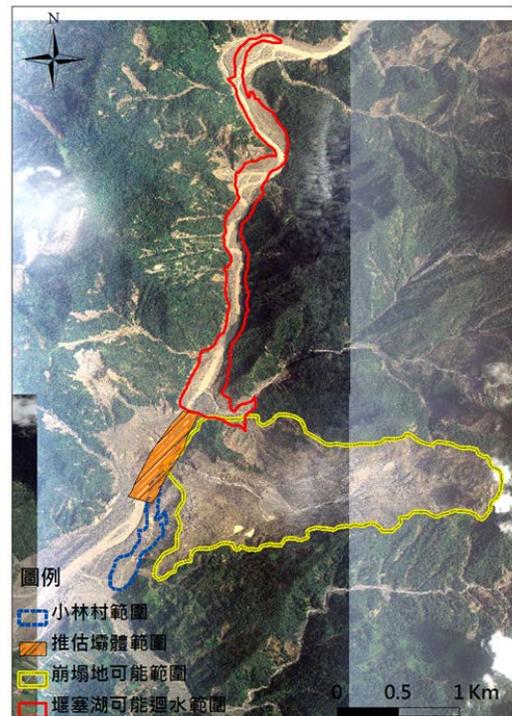
(a) Satellite image for analysis of natural dam (before Typhoon Morakot)

(b) Satellite image for analysis of natural dam (after Typhoon Morakot)

Figure 14 analysis figures of the investigated natural dam.

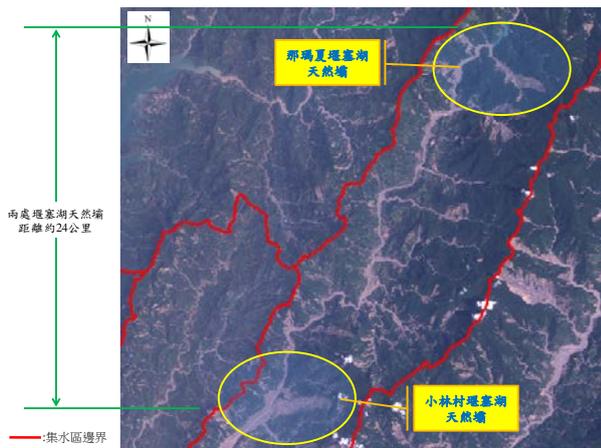
There were some natural dams formed by Typhoon Morakot (ref. figure 13). The dam break analysis was done by using PLAXIS model in combination with PLAXFLOW model. The coefficients for calculation are determined by satellite image processing (ref. figure 14), profile survey and soil material test. The simulated erosion process is shown in figure 15. According to the results, the storage capacity was full in 70-80 minutes after the dam was formed, and overflow occurred 70 minutes after the formation of the dam.

figure 13 2 natural dams at Cishan River

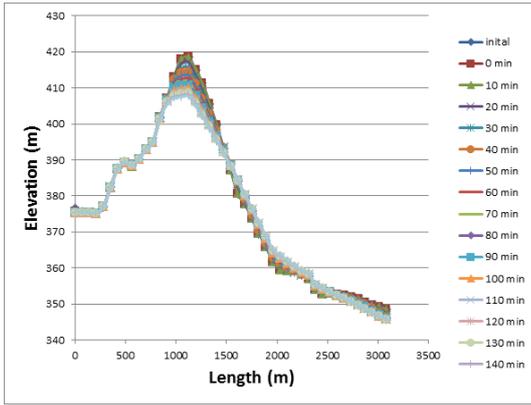
figure 15 simulated erosion process of the natural dam

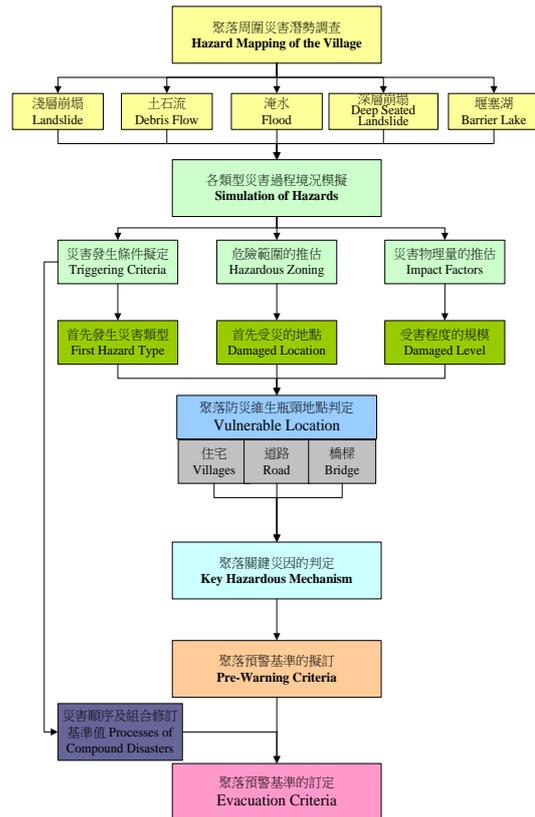
The event of Typhoon Morakot at Siaolin village is reconstructed by using the available reports and collected data. The disaster process and the occurrence mechanism are analyzed. The results could serve to improve the disaster response capability and warning and monitoring of compound disasters. It reveals that insufficiency of the present warning system and evacuation system. A strategy draft was suggested in figure 16.

Figure 16 guide scheme to cope with compound disasters
