MOBILIZATION AND ORGANIZATION OF PROFICIENTS TO COLLECT CRITICAL DATA IMMEDIATELY AFTER A NATURAL DISASTER

MingHung CHEN, ChungYue WANG, ChingLung LIAO
China Engineering Consultants, Inc., Taiwan

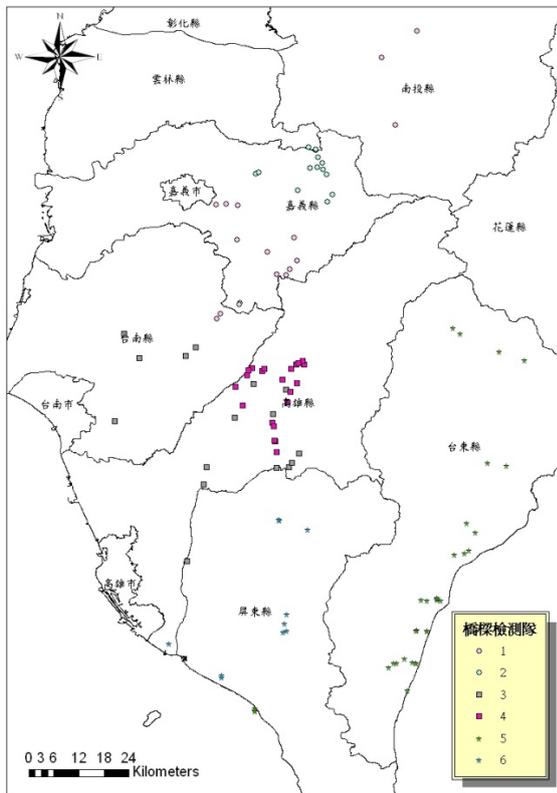
Figure 1 Location of damaged bridges investigated by 6 reconnaissance teams

The command center of the investigation action was set at CECI in Taipei. The command center had to understand the road condition to access to the bridges, to communicate with local highway agencies to search for help. All the information was delivered and returned to command center at the very first moment. Each reconnaissance team was composed by at least 4 members, led by a professor and a professional technician. Six teams were formed finally as listed in Table 1 and their survey areas are plotted in Figure 1.

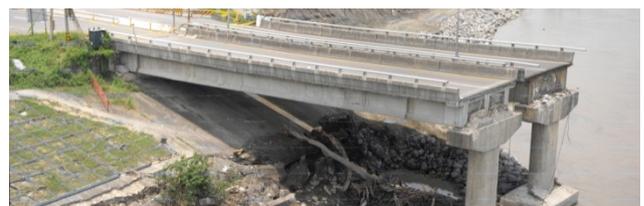
Figure 3 Shuang-Yuan Bridge failed in scoring photoed by AUMAV

The AUMAV is designed to perform tasks in the field of documentation, coordination, exploration, surveying, communication, inspection and observation. They can fly by remote control or autonomously with the aid of GPS waypoint navigation system. This equipment was provided by *LinkFast Technology Co. Ltd.* They helped to take aerial picture of Shuang-Yuan Bridge above the bridge, and represented an opposite viewpoint which cannot be seen from abutment as shown in Figure 3. Furthermore, they also took a long ride into deeply the severest disaster area, just to take another aerial picture of Namashia Township devastated by debris flow (Figure 4). Through such an aerial picture, the actual flood region as well as flow path could be recorded entirely.

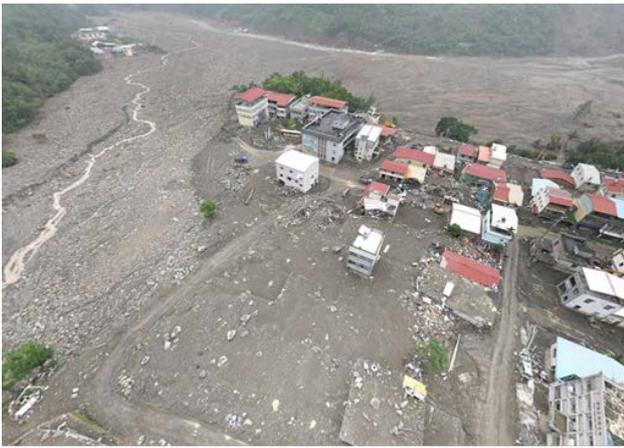
Figure 4 Namasia township swept by debris flow photoed by AUMAV

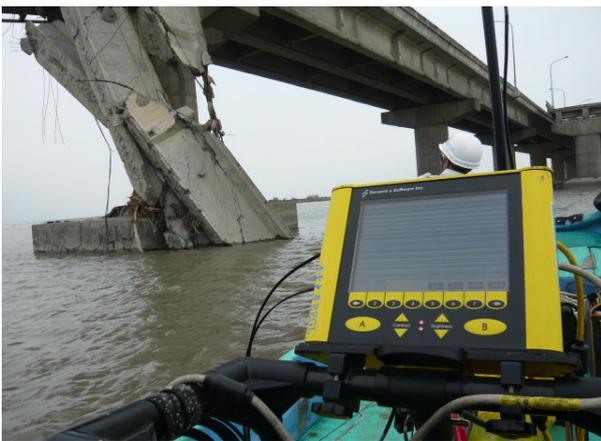
Inspections with underwater GPR, sonar, and ERI were performed for detecting the positions of breakage pieces and evaluating the scouring depth after the catastrophic failure at Shuang-Yuan Bridge. Underwater GPR inspection with different antenna frequencies, 200, 450, and 900 MHz, was conducted by *Ching Yun University* to measure the stream bed elevation on August 27th, 2009, as shown in Figure 5. A deepest depth 13 m between ex-foundation piers P15 and P16 was identified in the test. [*Helsin Wang et al., 2010*]

Figure 5 Underwater GPR and sonar inspection to Shuang-Yuan Bridge

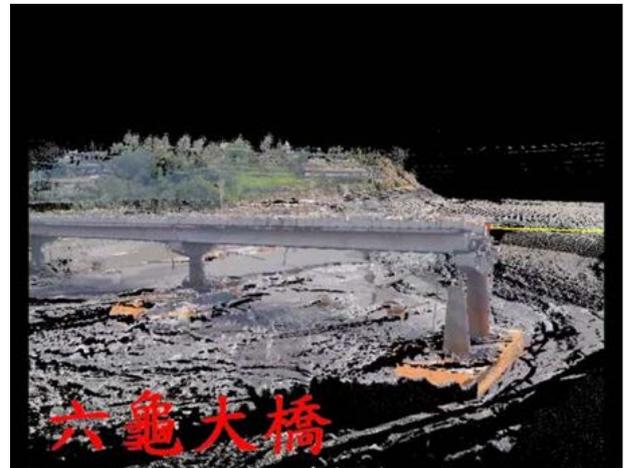
Figure 6 3D LiDar scanning result of Liouguei Bridge

of producing digital coordinate data of scanned target efficiently, and was employed to record some selected significant structures. *Strong Engineering Consulting Co., Ltd.* kindly assisted to scan Liouguei Bridge (Figure 6), ChiWei Bridge, ShinChiWei Bridge and Shuang-Yuan Bridge. *Ching Yun University* helped to scan Dajin Bridge and some highway slopes. These digital coordinate data can benefit greatly in building the numerical model for mechanism analysis and evaluation. *China University of Technology* utilized the point cloud and built a numerical model of Liouguei Bridge as illustrated in Figure 7.

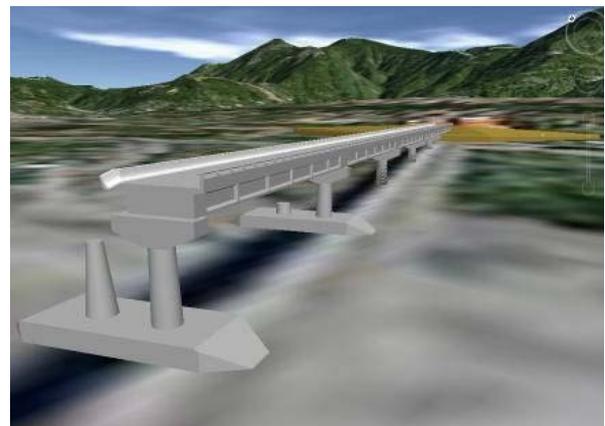
Figure 7 Numerical model of Liouguei Bridge

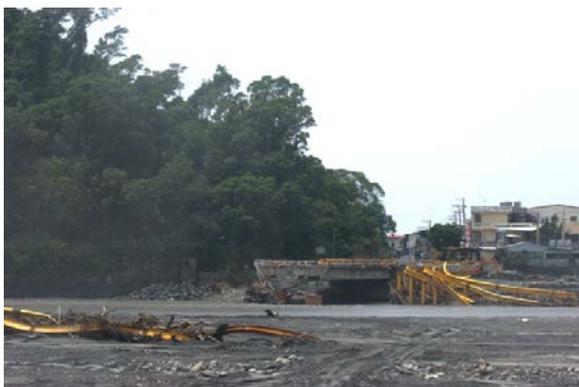
Figure 8 is a picture of Dajin temporary steel bridge destroyed in Morakot, which reveals the steel frame were bended by formidable force by debris flow. The deformed structure shape was scanned and recorded with 3D LiDar as Figure 9.

Figure 8 Severe debris flow destroyed Dajin temporary steel bridge

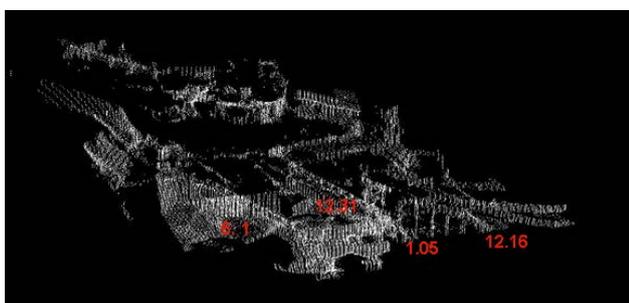
Figure 9 3D LiDar scanning result of the bended steel frames

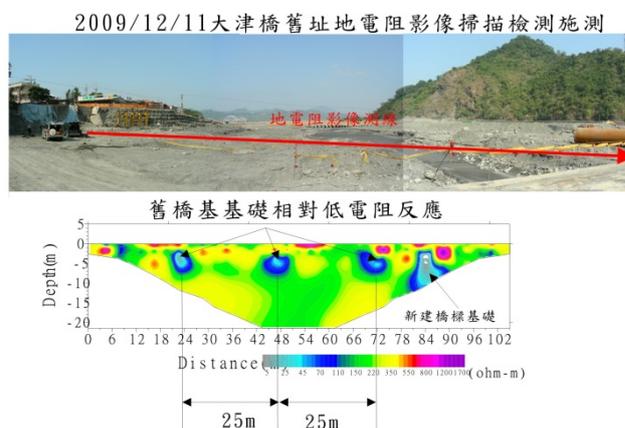
The ERI investigating result is presented in Figure 10. The electrodes were placed along the pier foundation (if existed), and the image profile was displayed in contour map. From this survey, the pier foundations of Dajin Bridge were clearly observed at the spacing of 25 m and to depth of around 5 m. According to the straight evidence, the bridge designer for reconstruction can be confident with the scour depth was not too deep in that event.

Figure 10 RIP investigating result of the existed pier foundations of Dajin Bridge

People wondered if the pier foundations of Dajin Bridge were totally flushed away in the flood, or still existed beneath the ground. Because the truly failure

mode needs to be proven by exactly exploring the existence of foundations. For that reason, ERI investigation is a rather economic and confident method to answer this tough question.
