RATIONAL MAINTENANCE SYSTEM FOR CONCRETE BRIDGES DETARIORATED BY SALT ATTACK ON THE COAST OF JAPAN SEA

Yasushi TANAKA*, Kou IBAYASHI**, Osamu YOUDA*** and Kyuichi MARUYAMA*

Nagaoka University of Technology*

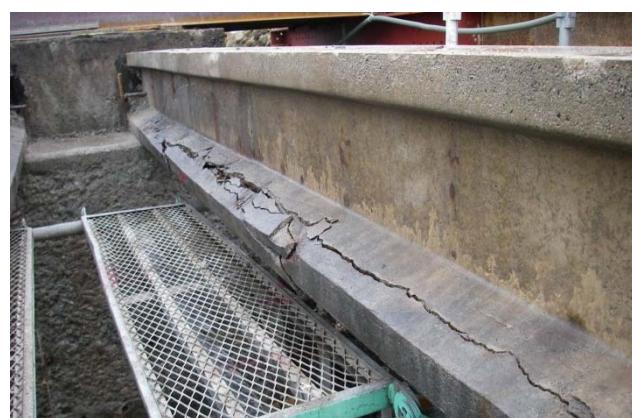
Figure1 an example of deteriorated PC bridge beam affected by salt attack in Niigata pref., Japan (constructed in 1975)

In Japanese coastal area, concrete bridges, which were constructed in 1960's and 1970's, are now deteriorated by salt attack as shown in Figure1. High concentration of chloride ion accelerates corrosion of reinforcing materials inside concrete structures.

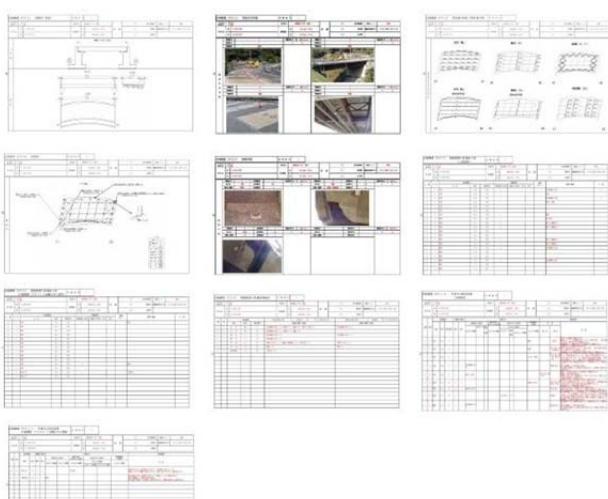
Figure7 an example of inspection report according to the form prescribed in Niigata pref.

It is time-consuming work to make the inspection report. Figure7 shows an example of inspection report according to the form prescribed in Niigata prefecture. Other than inspection results, inspector must collect many relating data according to defined format. This report should be prepared for every bridge.

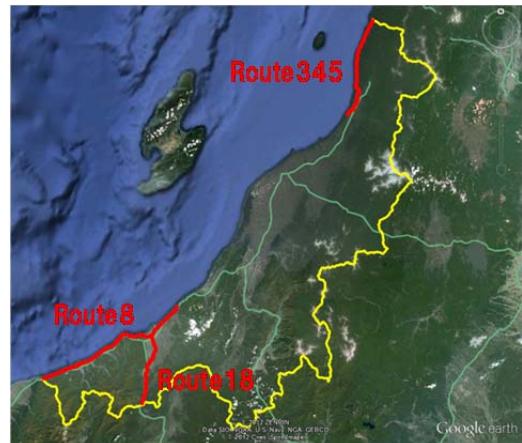
Figure 15 surveyed national route

Because inspection data had not been stored until recently, it is impossible to evaluate the durability of repaired bridges quantitatively. Instead, we collected construction cost and repair cost stored in road administrator office. Then, we calculated actual maintenance cost for each bridge. As shown in Figure 15, National route 8, 18 and 345 were surveyed in this study. The value of currency changes day by day. Therefore, construction cost and repair cost was converted to present value with Corporate Goods Price Index (CGPI) as shown in Figure 16.

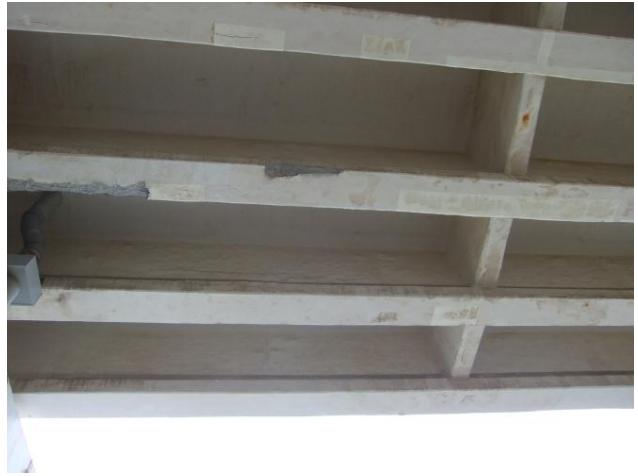
(a) patching and painting (7th span)

Figure19 repair method in B bridge

In case of B bridge, two types of repairing methods were used. As shown in Figure19 (a), patching and painting repairs were applied except 8th span. 8th span was repaired by cathodic protection. Total cost of each span is compared in Figure20. Cathodic protection was applied 23 years after construction. Although cost of cathodic protection is higher than patching and painting repairs, maintenance cost after repair is cheap and re-deterioration has not occur until now in 8th span. On the other hand,

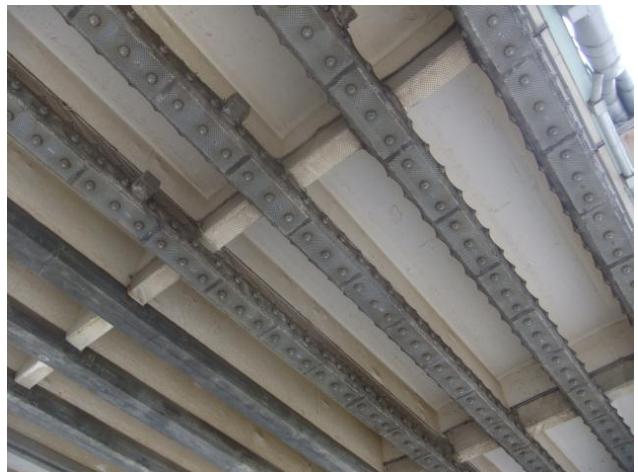
(b) cathodic protection (8th span)
