The restoration of sediment-related disasters and driftwood from national forest in Taiwan caused by Typhoon Morakot in 2009

Su Chin Chen *, Jau Pao Wang **, Chun Hsien Yang **

Forestry Bureau, Council of Agriculture, Executive Yuan**

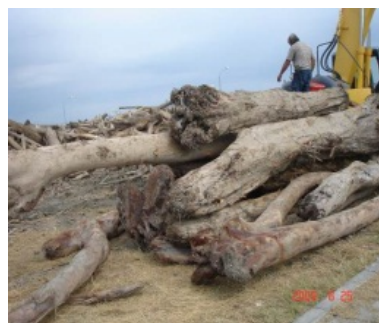
Fig3.1 Gathering woody debris from Yanpu Fishing Harbor for shipment. Most of this wood consists of highly abraded tree trunks with the roots still attached.

The first priority consisted of the clean-up of navigation channels, followed by clean-up of entire harbors. A total of 52 fishing harbors clogged with woody debris were distributed in 10 cities and counties, and included such major fishing harbors as Fugang in Taitung County and Yanpu in Pingtung County. Working 12 hours a day, navigation channels were cleared by August 18, enabling fishermen to get to fishing and restoring the transport of supplies to Lanyu and Green Island by ship. All woody debris was subsequently removed from fishing harbors, and any woody debris that floats into a harbor from offshore is promptly removed (Fig 3.1).

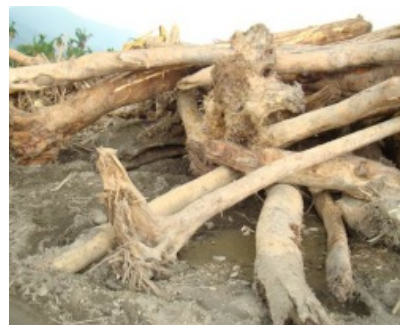
Fig3.2 Woody debris in Xinfeng Village, Gaoshu Township. Most of the wood consists of trunks with attached roots, and there are no saw marks.

first record the presence of any valuable wood and then remove all woody debris. In the wake of Typhoon Morakot, however, all woody debris was removed, regardless of whether it contained valuable wood that could be sold at auction, and piled at storage yards; the wood was then recorded and subsequent handling procedures implemented (Fig 3.2).

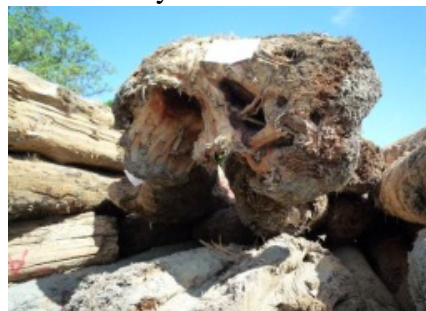
Fig3.4 Recorded valuable woody debris consisting of trunks with the roots still attached and constituting national property. The roots have been abraded into irregular forms. (photo taken in Taitung City)

According to Article 76 of the Water Utilization Act, the river management agency must remove any woody debris threatening river control on an emergency basis. Based on the fact that large amounts of woody debris were deposited in riverbeds by Typhoon Morakot, and the Water Resources Agency undertook many river management reconstruction and dredging projects in the wake of the typhoon, the Water Resources Agency also removed woody debris when implementing these projects or clearing sediment. Town and township public offers were assigned to clean up woody debris lying in riverside areas after joint surveys by river bureaus, city and county governments, and forest district offices (Fig 3.3 & 3.4).
