# QUANTIFICATION OF CHANGES IN SURFACE CONDITIONS OF AIRPORT PAVEMENTS IN JAPAN

Yoshitaka HACHIYA, Takashi WATANABE and Kentaro KITAOCHI  
Service Center of Port Engineering (SCOPE), JAPAN

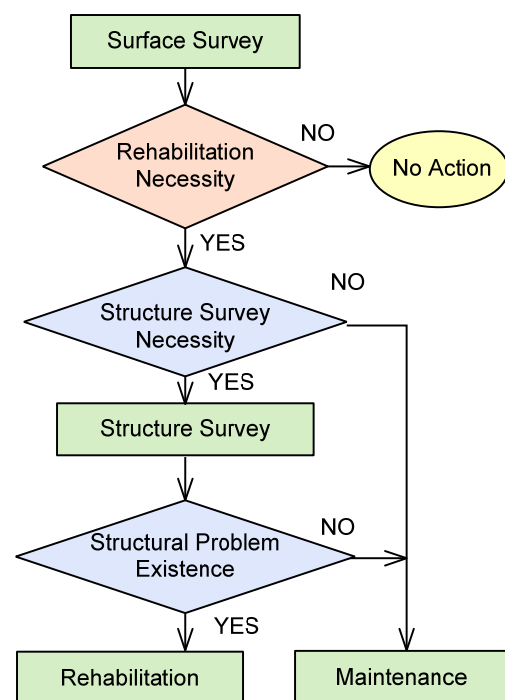
**Figure 1** shows a flow chart of the evaluation and rehabilitation subsystems, in which fundamental evaluation, and maintenance and rehabilitation process consists of the following steps.

**Figure 1** Flow chart of evaluation and rehabilitation subsystems for airport pavement management

The condition of the airport pavement surface is surveyed every three years. When the physical condition of the surface is judged to have seriously deteriorated, certain rehabilitation work may become necessary. In order to determine a suitable time for carrying out this rehabilitation work, an objective method using the already-mentioned PRI has to be applied.

If the above-mentioned PRI method indicates that certain rehabilitation work is necessary, the structural condition of the pavement has to be checked. Non-destructive testing procedures using a Falling Weight Deflectometer (FWD) are adopted for airport pavements.

If the structural condition of a pavement is found to be unsound, rehabilitation work is necessary. However, some maintenance work may be needed even if the pavement is sound structurally.

Based on the decision made above, the procedure for the rehabilitation work should be determined. In general, there are two methods of rehabilitation, overlay and reconstruction.

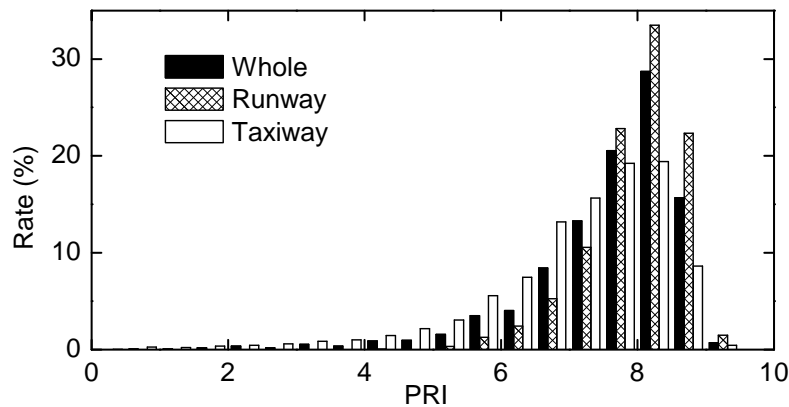
**Figure 2** shows the survey results for the state of the asphalt pavement at 23 of these airports, conducted between 1998 and 2002. The PRI values for runways and taxiways are different, with runways averaging 8.0 and taxiways 7.1. There is a difference of about ten percent on average between runways and taxiways, with taxiways exhibiting the smaller

values of PRI. All types of distress, including cracking, rutting, and roughness, are more severe on taxiways than on runways and this is reflected in the PRI.

**Figure 2** PRI Distribution

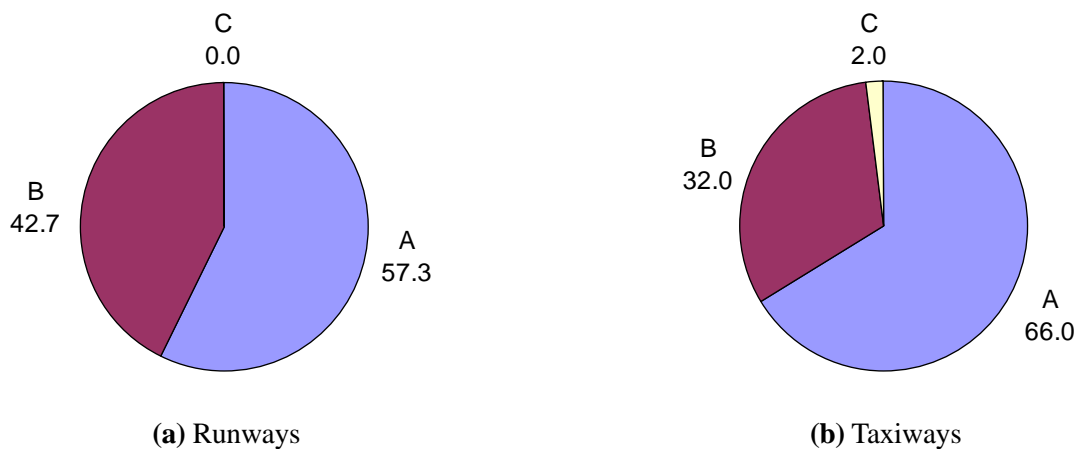
**Figure 3** shows the need for rehabilitation work as judged from these PRI values in accordance with the criteria given in **Table 1**. Looking at runways, the proportion of pavements classified as A is about 60% and the remainder is B. On the other hand, about 70% of taxiway pavements are ranked as A, but there are some ranked as C. Although PRI values are smaller for taxiways than for runways, the difference in need for rehabilitation results from the different criteria used for runways and taxiways.

**Figure 3** Need for Rehabilitation Work

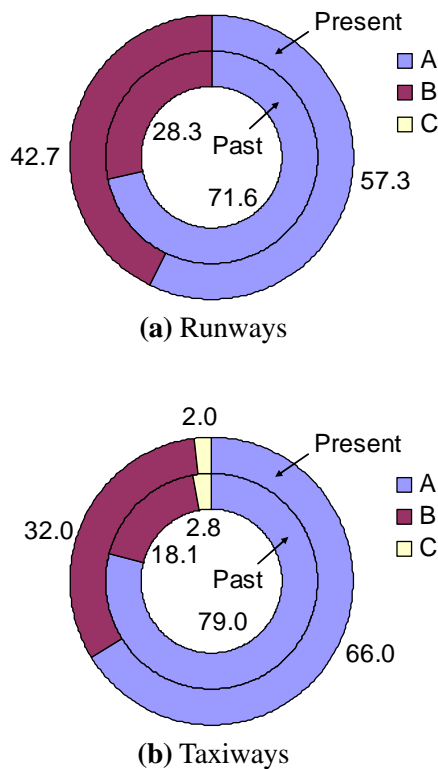
**Figure 4** summarizes the need for rehabilitation work based on PRI. The proportion judged as A is ten points or more lower now than in the past survey, both for runways and taxiways, while there are more B ranks today. However, there is little difference in the proportion judged as C between the current and past surveys.

Clearly, the condition of airport pavement surfaces has worsened in the 20 years since the earlier survey, with the proportion ranked as B increasing over the years. This might suggest that the pavement management system, including the methodology

**Figure 4** Comparison of Judged Need for Rehabilitation Present and Past

used to evaluate pavements (the method and the survey interval) is barely adequate to maintain the surface in good condition.

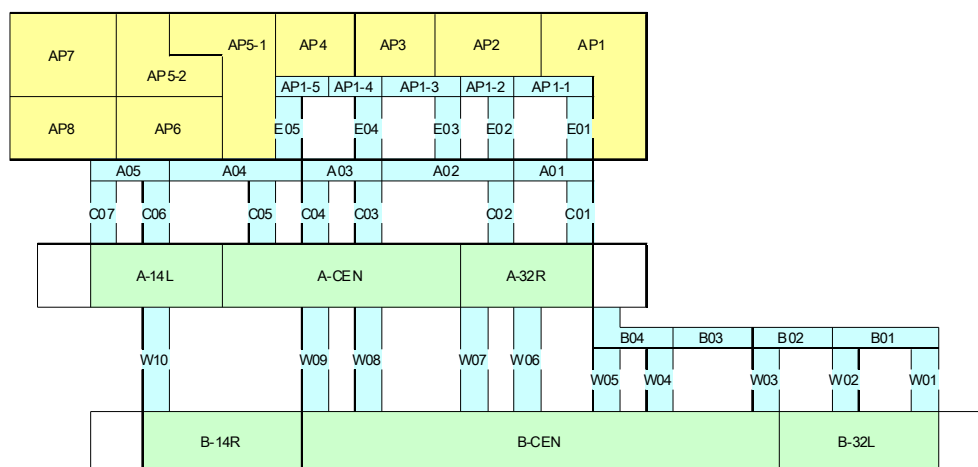
The surface conditions of runways, taxiways and aprons were evaluated in 163, 273, 101 units, respectively. When the annual changes in PRI and the recovery of PRI due to rehabilitation works are analyzed in each unit, the results vary largely. Thus, the units are summed into several groups as shown in **Figure 5**. The runways A and B were separated into three blocks (two end parts and one intermediate part) in each, and the aprons were divided into nine blocks in consideration of the aircraft running lines. The taxiways were divided into perpendicular taxiways, high-speed exit taxiways and parallel taxiways.

When calculating the annual change in PRI, only the data measured in three or more times between the continuous rehabilitation works are used. For asphalt pavements, the average annual changes in PRI for runways, taxiways are 0.1 - 0.2, 0.1 - 1.2, respectively. The recovered amount of PRI by applying the rehabilitation works scarcely varies in rehabilitation works conducted at Osaka Itami Airport.

**Figure 5** Groups for PRI calculation at Osaka Itami Airport
